BC TIMBER SALES CHINOOK BUSINESS AREA

MT. ELPHINSTONE SOUTH
WATERSHED ASSESSMENT:
PHASES 1 & 2 (VOLUME 2)

Polar File: 740201
MARCH 2023

APPENDIX F: SELECTED PHOTOS

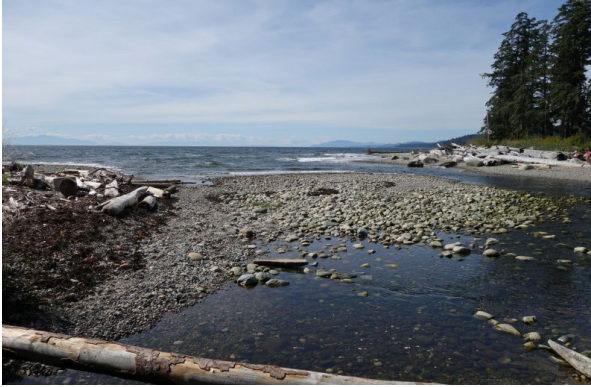
FIGURE 001

Photo: DSC09993
Date (YYYY MM DD): 2020 08 26
Location: **Chaster Cr, km 0.00**
View direction: West
Description:
Mouth of Chaster Creek

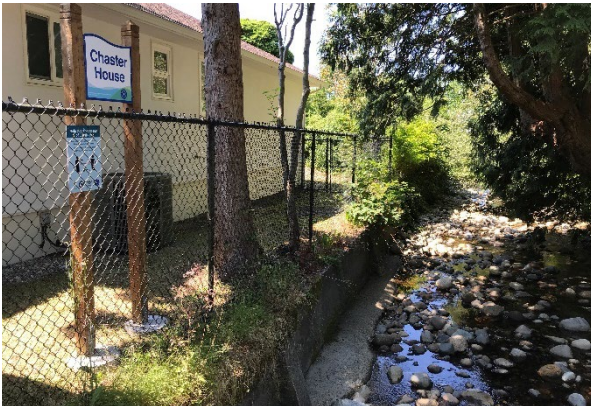
FIGURE 002

Photo: DSC09983
Date (YYYY MM DD): 2021 07 12
Location: **Chaster Cr, km 0.02**
View direction: Downstream
Description:
Retaining wall along Chaster House near mouth.

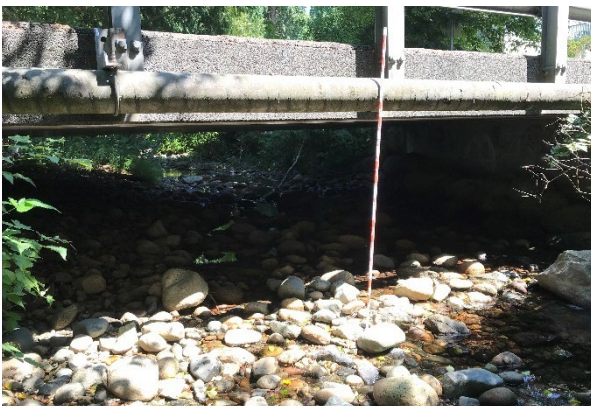
FIGURE 004

Photo: IMG_3926
Date (YYYY MM DD): 2021 07 12
Location: **Chaster Cr, km 0.04**
View direction: Upstream
Description:
Ocean Beach Esplanade bridge over Chaster Creek.

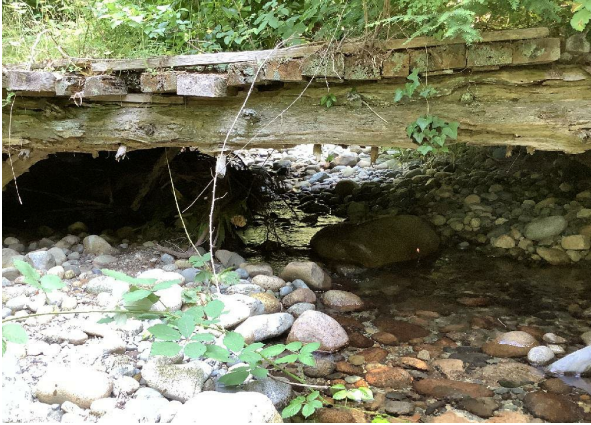
FIGURE 005

Photo: IMG_3931
Date (YYYY MM DD): 2021 07 12
Location: **Chaster Cr, km 0.10**
View direction: Upstream
Description:
Old private bridge over Chaster Creek.

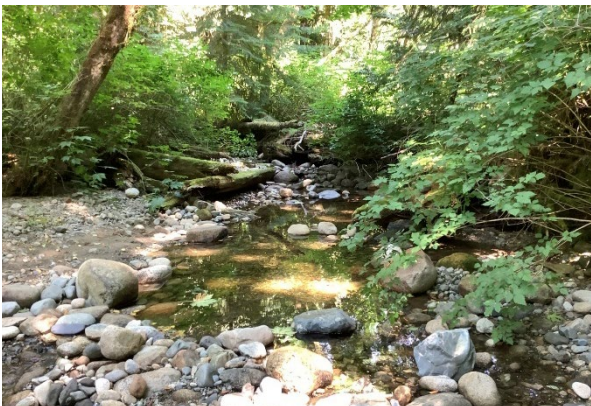
FIGURE 008

Photo: IMG_4509
Date (YYYY MM DD): 2021 07 12
Location: **Chaster Cr, km 0.9**
View direction: Upstream
Description:
Below log jam.

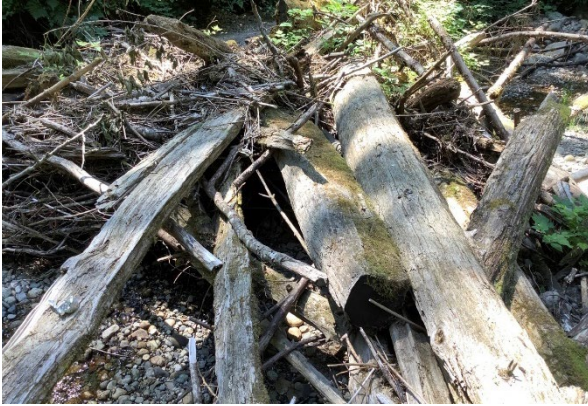
FIGURE 009

Photo: IMG_4512
Date (YYYY MM DD): 2021 07 12
Location: **Chaster Cr, km 0.9**
View direction: Upstream
Description:
Log jam

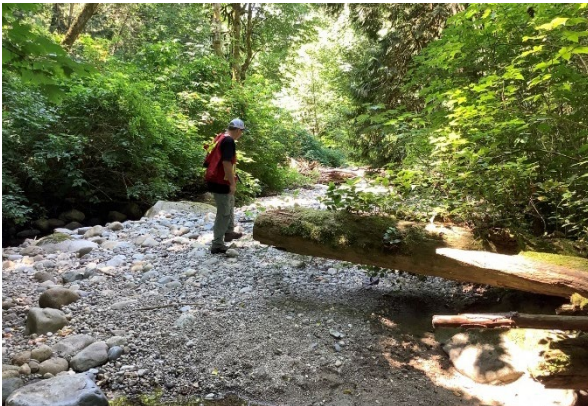
FIGURE 010

Photo: IMG_4510
Date (YYYY MM DD): 2021 07 12
Location: **Chaster Cr, km 0.9**
View direction: Downstream
Description:
Sediment wedge above log jam.

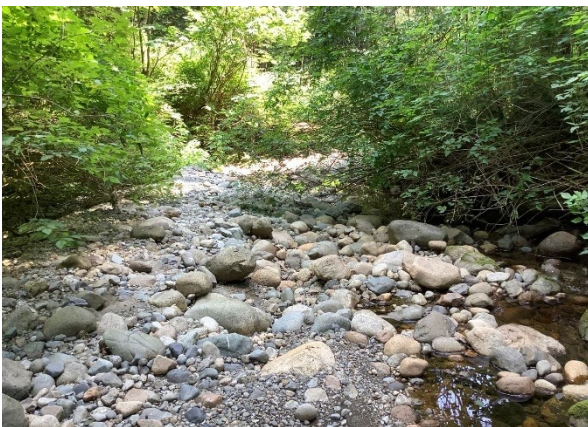
FIGURE 012

Photo: IMG_4520
Date (YYYY MM DD): 2021 07 12
Location: **Chaster Cr, km 1.6**
View direction: Downstream
Description:
Sediment wedge

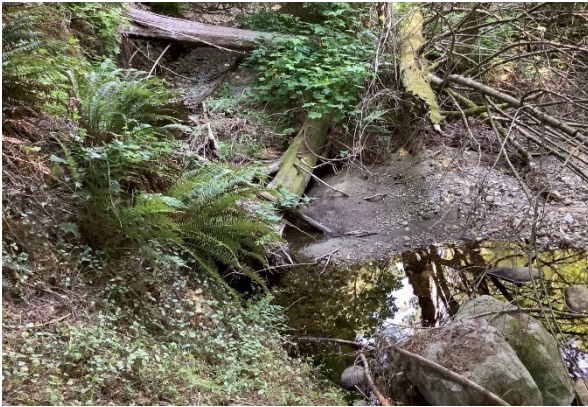
FIGURE 014

Photo: IMG_4532
Date (YYYY MM DD): 2021 07 12
Location: **Chaster Cr, km 2.6**
View direction: Upstream
Description:
Log jam and sediment wedge

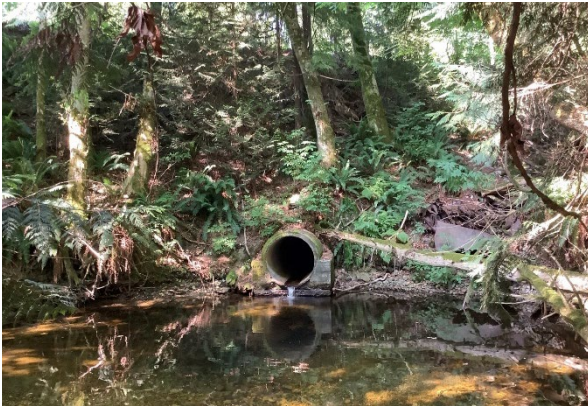
FIGURE 015

Photo: IMG_4527
Date (YYYY MM DD): 2021 07 12
Location: **Chaster Cr, km 2.6**
View direction: Upstream
Description:
900 mm diameter concrete culvert beneath Sunshine Coast Highway.

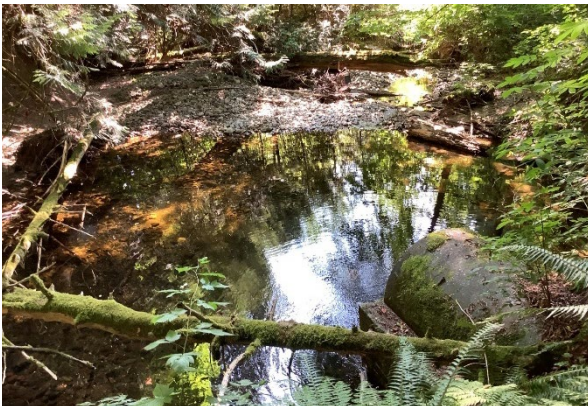
FIGURE 016

Photo: IMG_4525
Date (YYYY MM DD): 2021 07 12
Location: **Chaster Cr, km 2.6**
View direction: Downstream
Description:
Pool below highway crossing.

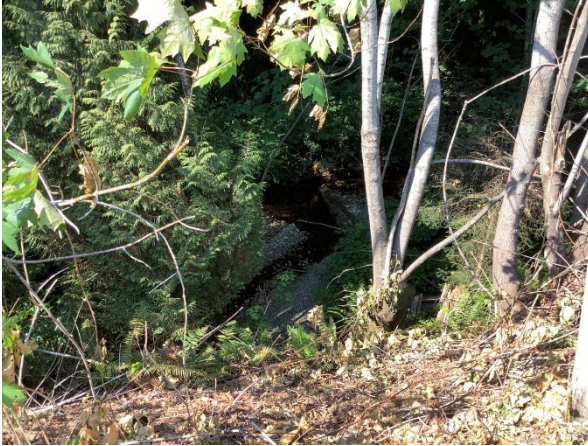
FIGURE 017

Photo: IMG_4534
Date (YYYY MM DD): 2021 07 12
Location: **Chaster Cr, km 2.7**
View direction: Upstream
Description:
Above highway crossing.

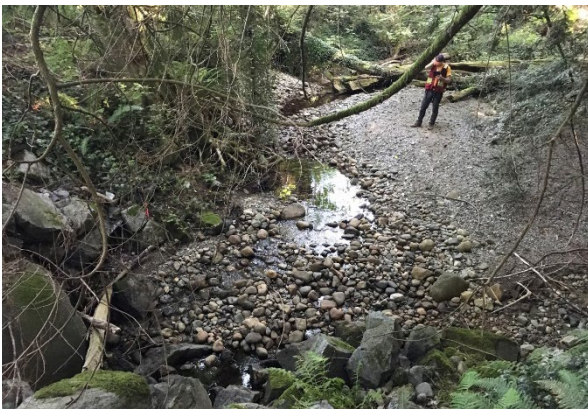
FIGURE 018

Photo: IMG_2005
Date (YYYY MM DD): 2021 07 13
Location: **Chaster Cr, km 2.9**
View direction: Upstream
Description:
Above Henry Road culvert.

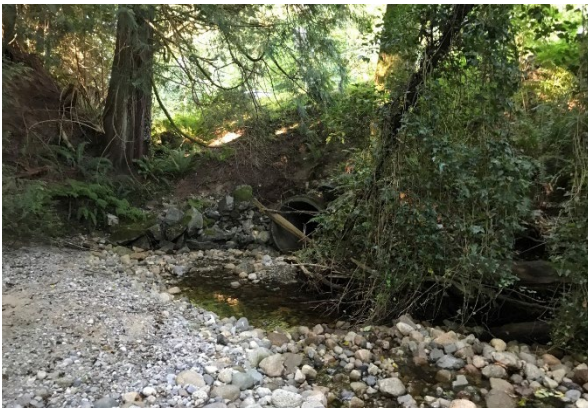
FIGURE 019

Photo: IMG_2008
Date (YYYY MM DD): 2021 07 13
Location: **Chaster Cr, km 2.9**
View direction: Downstream
Description:
Henry Road culvert.

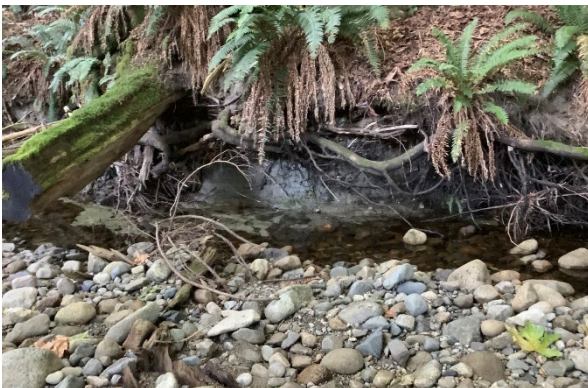
FIGURE 020

Photo: IMG_4563
Date (YYYY MM DD): 2021 07 13
Location: **Chaster Cr, km 2.9**
View direction: South
Description:
Clay layer on streambank.

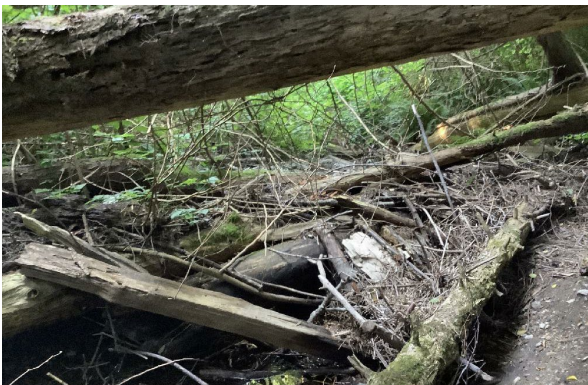
FIGURE 033

Photo: Placemark 33
Date (YYYY MM DD): 2021 07 16
Location: **Chaster Tributary 4.1 (Shirley Cr), km 2.4**
View direction: Downstream
Description:
 Log jam with sediment wedge.

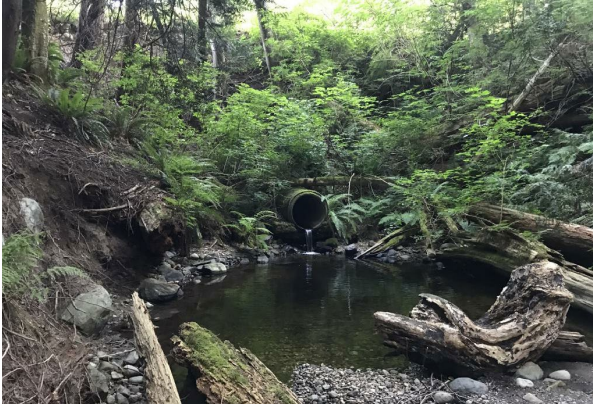
FIGURE 034

Photo: Placemark 2
Date (YYYY MM DD): 2021 07 16
Location: **Chaster Tributary 4.1 (Shirley Cr), km 2.55**
View direction: Upstream
Description: 900 mm diameter concrete culvert beneath Sunshine Coast Highway.

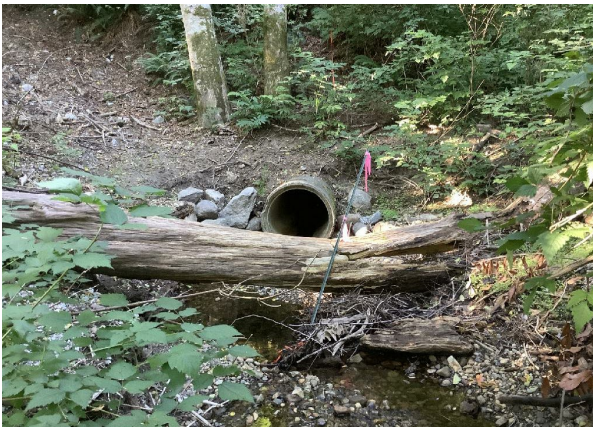
FIGURE 037

Photo: Placemark 34
Date (YYYY MM DD): 2021 07 16
Location: **Chaster Tributary 4.1 (Shirley Cr), km 2.6**
View direction: Downstream
Description: 900 mm diameter concrete culvert beneath Sunshine Coast Highway.

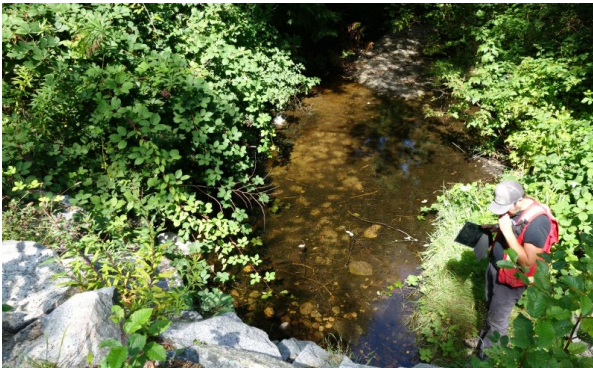
FIGURE 039

Photo: DSC09969
Date (YYYY MM DD): 2020 08 26
Location: **Chaster Tributary 4.1 (Shirley Cr), km 3.0**
View direction: Upstream
Description: Above Russell Road culvert.

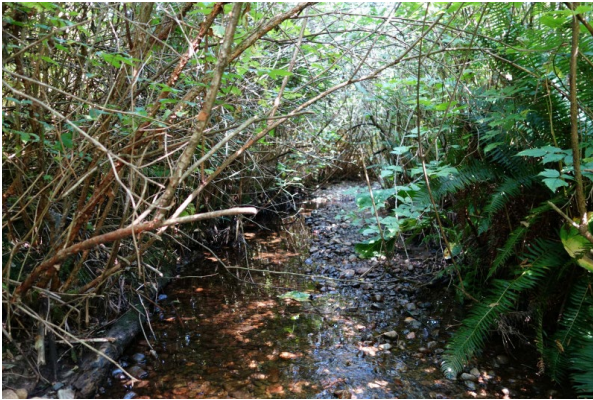
FIGURE 043

Photo: DSC09962
Date (YYYY MM DD): 2020 08 24
Location: **Chaster Tributary 4.1.2 (Webb Brook), km 3.2**
View direction: Upstream
Description:
Above Russell Road culvert.

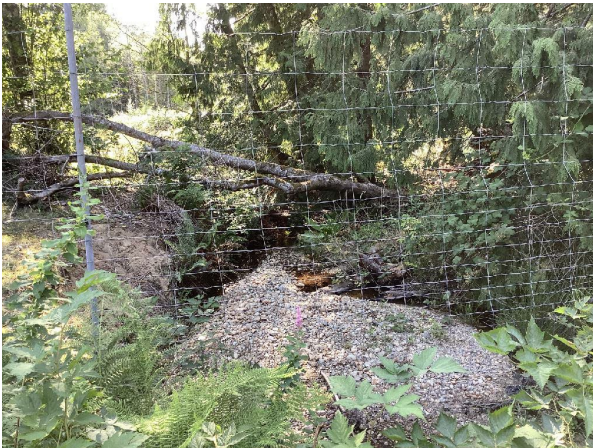
FIGURE 044

Photo: Placemark XX
Date (YYYY MM DD): 2021 07 16
Location: **Chaster Tributary 4.1.2.2 (Tretheway Spring), km 3.5**
View direction: Upstream
Description:
View from Henry Road culvert crossing.

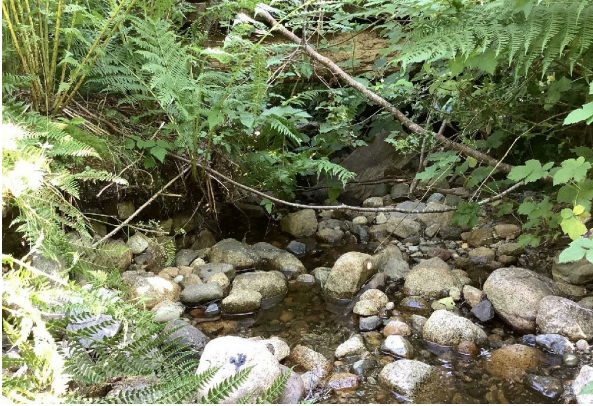
FIGURE 046

Photo: Placemark XX
Date (YYYY MM DD): 2021 07 16
Location: **Chaster Tributary
4.1.2.2 (Tretheway
Spring), km 3.8**
View direction: Downstream
Description:
Private bridge near residence at 1216 Reed
Road.

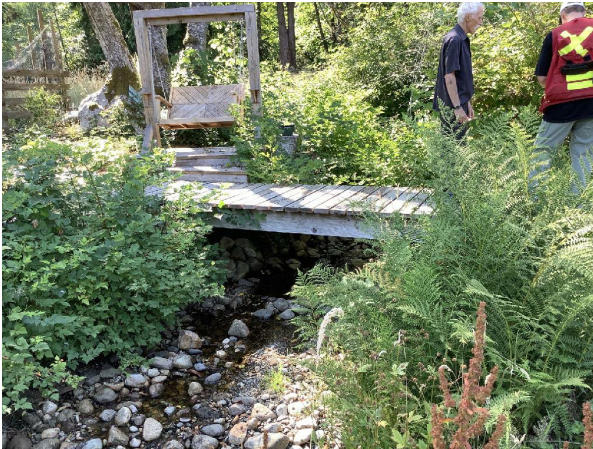
FIGURE 047

Photo: Placemark XX
Date (YYYY MM DD): 2021 07 16
Location: **Chaster Tributary
4.1.2.2 (Tretheway
Spring), km 3.9**
View direction: Downstream
Description:
One of several bridges near residence at 1216
Reed Road.

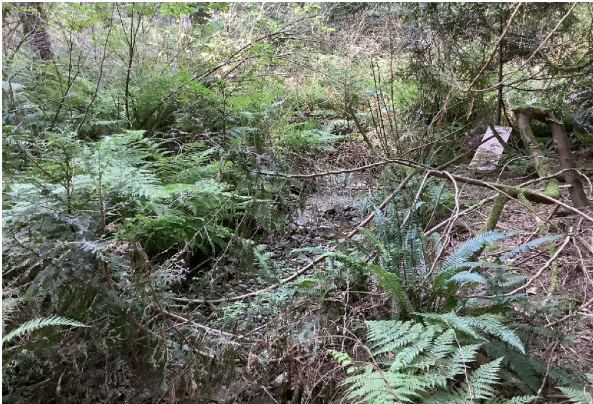
FIGURE 048

Photo: Placemark XX
Date (YYYY MM DD): 2021 07 16
Location: **Chaster Tributary
4.1.2.2 (Tretheway
Spring), km 4.1**
View direction: Upstream
Description:
View of mostly dry channel above residence at
1216 Reed Road.

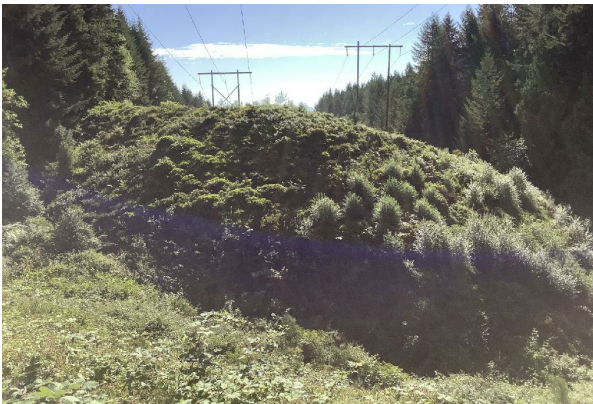
FIGURE 049

Photo: Placemark 43
Date (YYYY MM DD): 2021 07 16
Location: **Chaster Tributary
4.1.2.2 (Tretheway
Spring), km 4.5**
View direction: East
Description:
Deep ravine at hydro right-of-way.

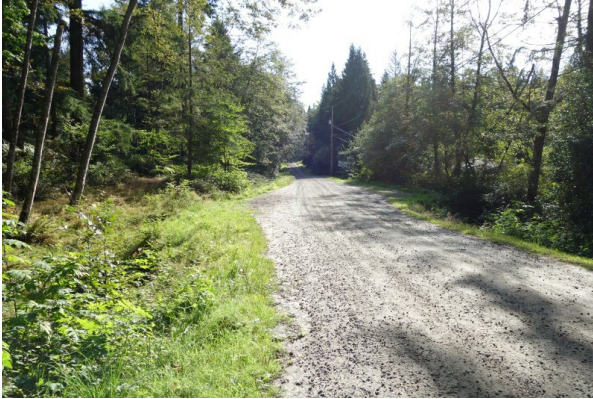
FIGURE 050

Photo: DSC09832
Date (YYYY MM DD): 2020 08 16
Location: **Chaster Tributary**
4.1.1.1, km 3.55
View direction: East
Description:
 Reed Road at culvert crossing of Chaster
 Tributary 4.1.1.1.

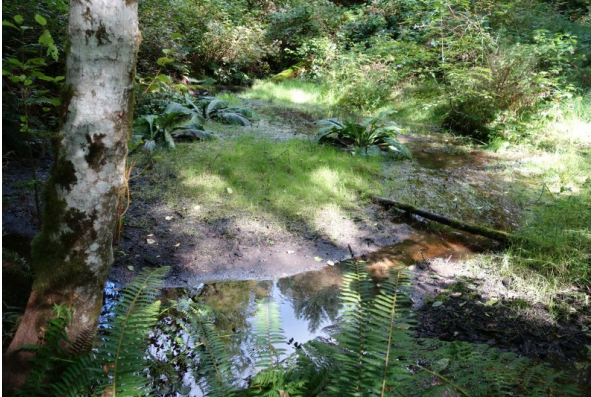
FIGURE 054

Photo: DSC09885
Date (YYYY MM DD): 2020 08 16
Location: **Chaster Tributary
4.1.1.1.1 (Inge Creek),
km 4.2**

Small pond and water intake (water licence C015414). Sedimentation has all but eliminated storage capacity of the pond.

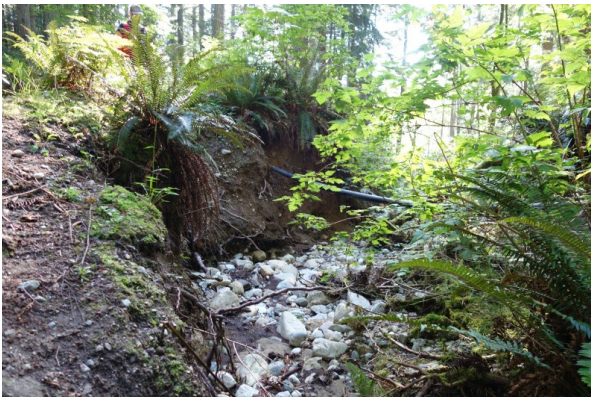
FIGURE 057

Photo: DSC09863
Date (YYYY MM DD): 2020 08 16
Location: **Chaster Tributary
4.1.1.1.2, km 3.65**

Trail and water supply line crossing. Near-vertical eroding banks noted.

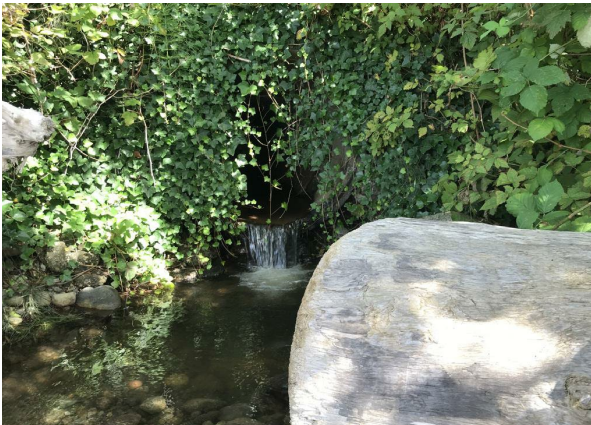
FIGURE 075

Photo: Placemark 138
Date (YYYY MM DD): 2020 08 24
Location: **End/Walker Cr, km 0.0**
View direction: Upstream
Description:
Culvert at Ocean Beach Esplanade.

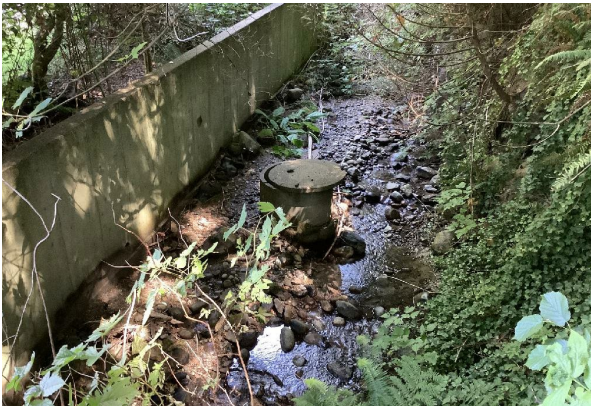
FIGURE 076

Photo: Placemark 57
Date (YYYY MM DD): 2020 08 27
Location: **End/Walker Cr, km 0.05**
View direction: Upstream
Description:
Retaining wall along property on north side of creek.

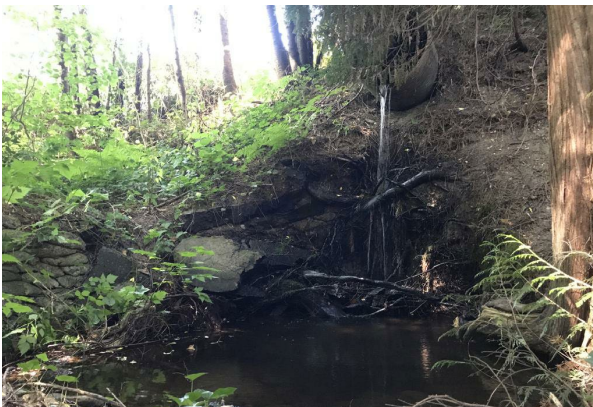
FIGURE 080

Photo: Placemark 15
Date (YYYY MM DD): 2021 07 16
Location: **End/Walker Cr,
 Unnamed Tributary
 branching off at km
 1.2**
View direction: Upstream

Description:
 1.2 m diameter culvert hanging 4 m above
 plunge pool below Sunshine Coast Highway.

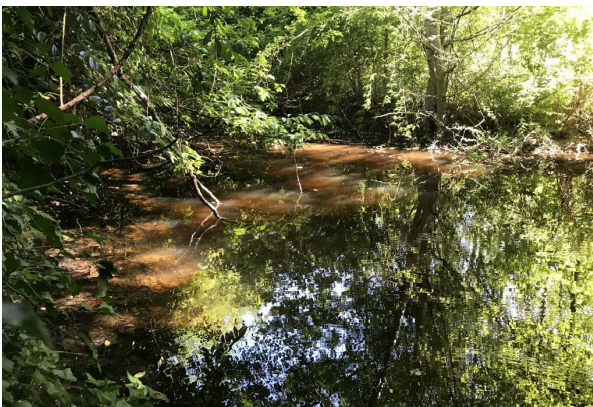
FIGURE 081

Photo: Placemark 17
Date (YYYY MM DD): 2021 07 16
Location: **End/Walker Cr,
 Unnamed Tributary
 branching off at km
 1.4**
View direction: Upstream

Description:
 Small reservoir controlled by concrete weir.
 Heavy brush. Water licence F016236.

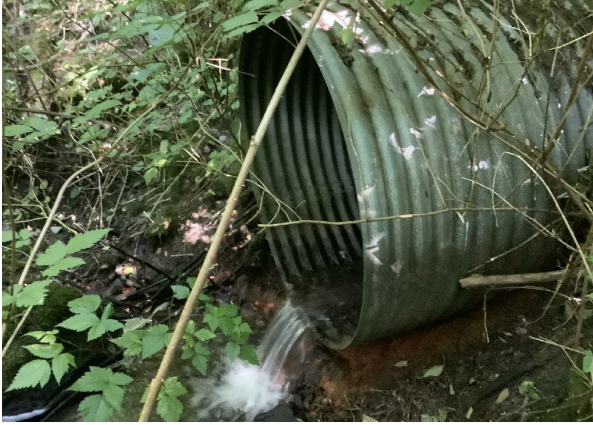
FIGURE 082

Photo: Placemark 53
Date (YYYY MM DD): 2021 07 16
Location: **End/Walker Cr, km 1.4**
View direction: Upstream
Description:
1200 mm culvert at Sunshine Coast Highway.

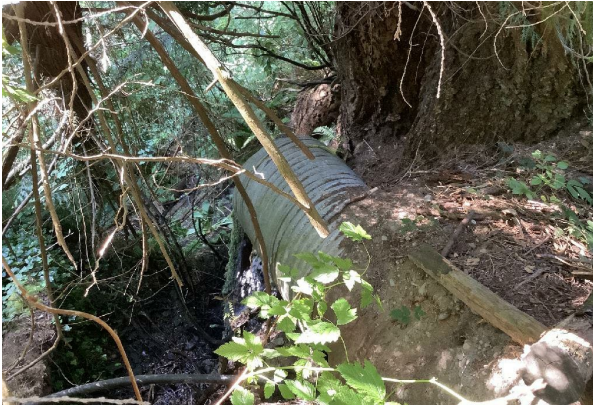
FIGURE 083

Photo: Placemark 51
Date (YYYY MM DD): 2021 07 16
Location: **End/Walker Cr, km 1.6**
View direction: Downstream
Description:
View below Russell Road 900 mm diameter hanging culvert.

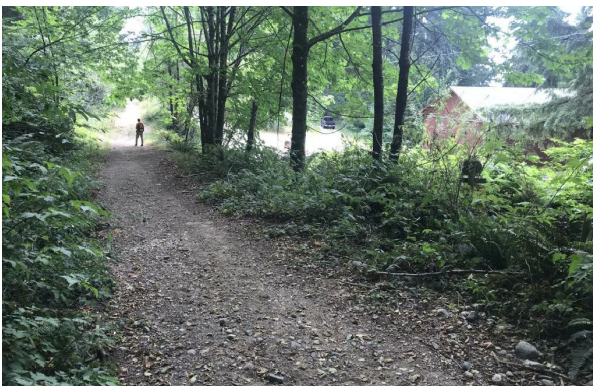
FIGURE 089

Photo: Placemark 218
Date (YYYY MM DD): 2021 07 16
Location: **End/Walker Cr watershed north of Reed Road**
View direction: West
Description:

Low point along road/trail where seasonally, runoff may cross the road.

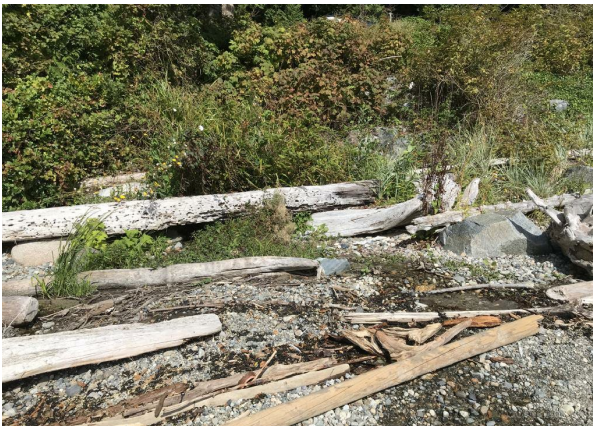
FIGURE 091

Photo: Placemark 139
Date (YYYY MM DD): 2021 07 16
Location: **Smales Cr, km 0.0**

Culvert at Ocean Beach Esplanade.

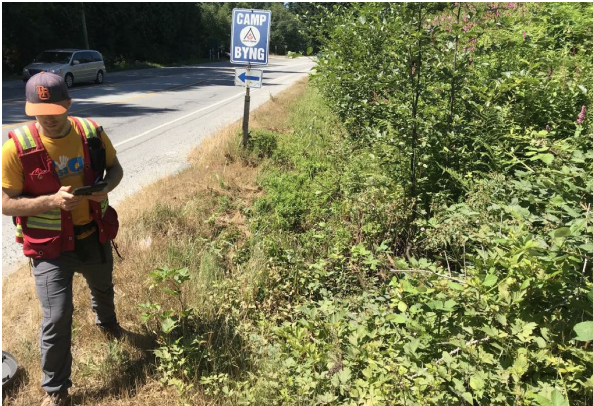
FIGURE 094

Photo: Placemark 22
Date (YYYY MM DD): 2021 07 16
Location: **Near Smales Cr, km 0.8**
View direction: West

Ditch along Sunshine Coast Highway that conveys runoff to the west towards Whittaker Creek. Most of the flow from Smales Creek however appears to flow to the east towards End/Walker Creek.

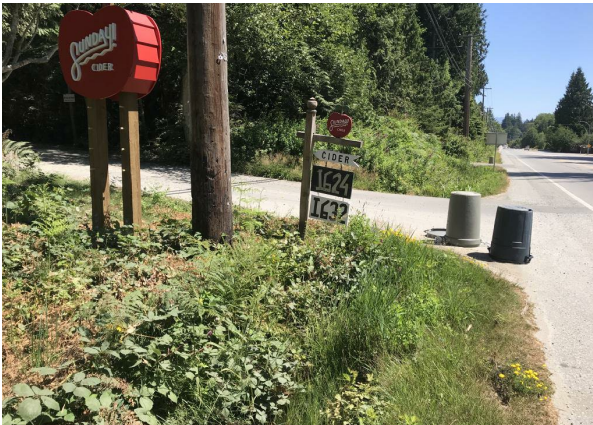
FIGURE 095

Photo: Placemark 24
Date (YYYY MM DD): 2021 07 16
Location: **Smales Cr, km 0.8**
View direction: West

Ditch along Sunshine Coast Highway that conveys Smales Creek runoff (from above the highway) to the east towards End/Walker Creek. No flow in Smales Creek above the highway appears to cross the highway.

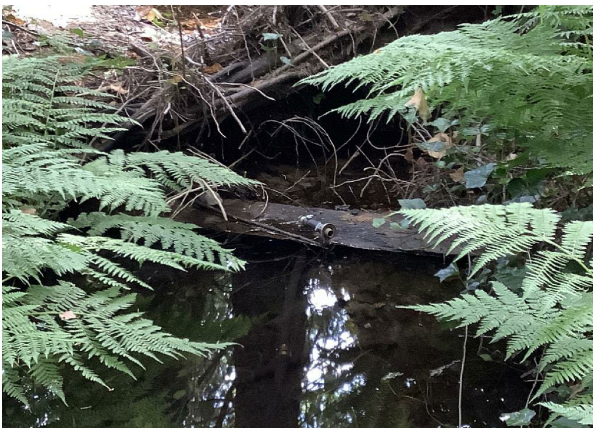
FIGURE 098

Photo: Placemark 226
Date (YYYY MM DD): 2021 07 16
Location: **Smales Cr, km 1.1**
View direction: Upstream
Description:
Water line along creek.

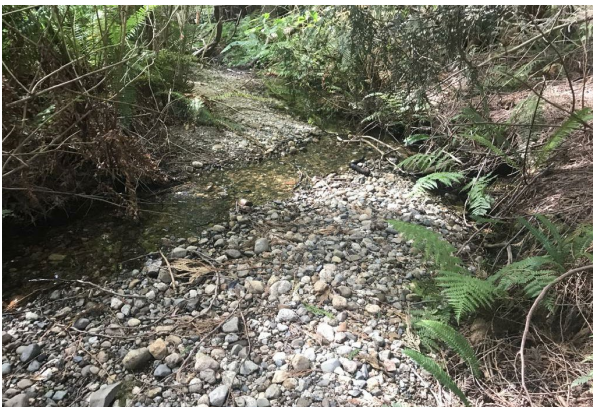
FIGURE 099

Photo: Placemark 212
Date (YYYY MM DD): 2021 07 16
Location: **Smales Cr, km 1.15**
View direction: Upstream
Description:
Aggraded stream channel.

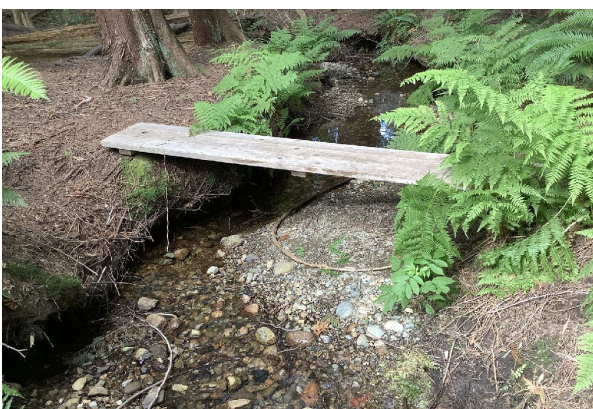
FIGURE 100

Photo: Placemark 224
Date (YYYY MM DD): 2021 07 16
Location: **Smales Cr, km 1.15**
View direction: Downstream
Description:
Foot bridge on Sunday Cider property.

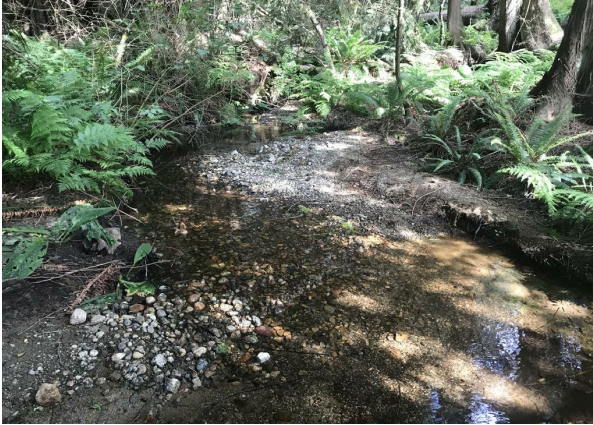
FIGURE 101

Photo: Placemark 211
Date (YYYY MM DD): 2021 07 16
Location: **Smales Cr, km 1.2**
View direction: Downstream
Description:
Aggraded stream channel.

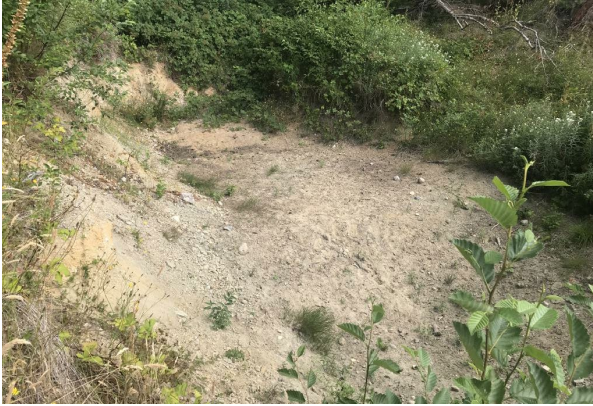
FIGURE 105

Photo: Placemark 209
Date (YYYY MM DD): 2021 07 16
Location: **Tributary to Smales Cr
that joins at km 1.3
(km 1.4)**
View direction: Upstream
Description:
Small sump/pond (dry).

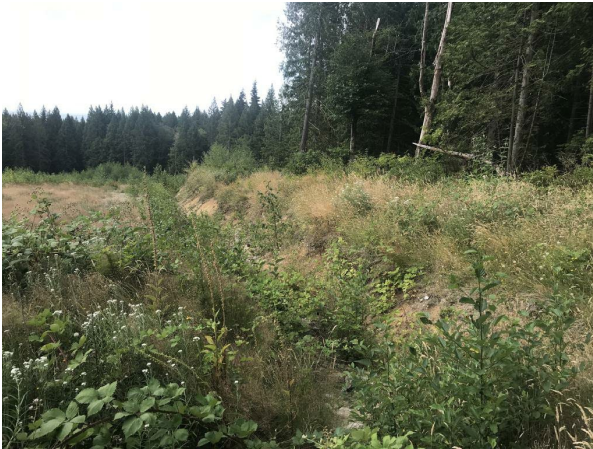
FIGURE 106

Photo: Placemark 209
Date (YYYY MM DD): 2021 07 16
Location: **Tributary to Smales Cr
that joins at km 1.3
(km 1.4)**
View direction: Downstream
Description:
Eroded channel below small sump/pond
(dry).

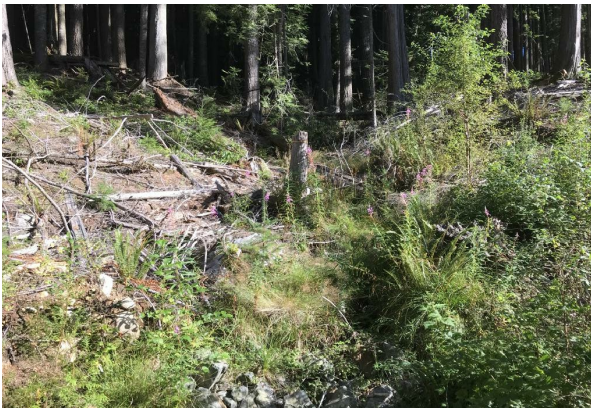
FIGURE 114

Photo: Placemark 161
Date (YYYY MM DD): 2021 07 16
Location: **Smales Cr Tributary 2, km 3.4**
View direction: Upstream
Description:
 View above 900 mm culvert.

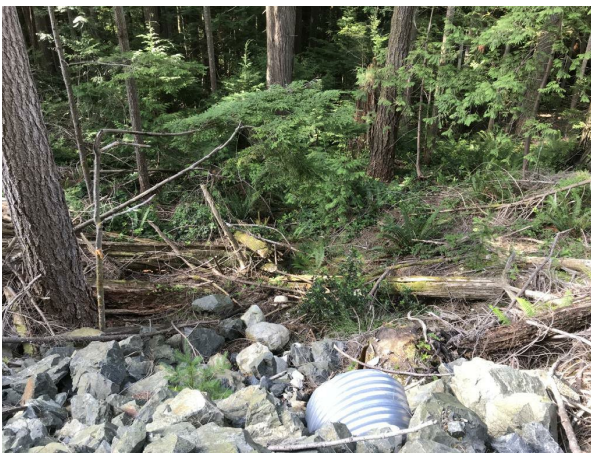
FIGURE 115

Photo: Placemark 161
Date (YYYY MM DD): 2021 07 16
Location: **Smales Cr Tributary 2, km 3.4**
View direction: Downstream
Description:
 View below 900 mm culvert.

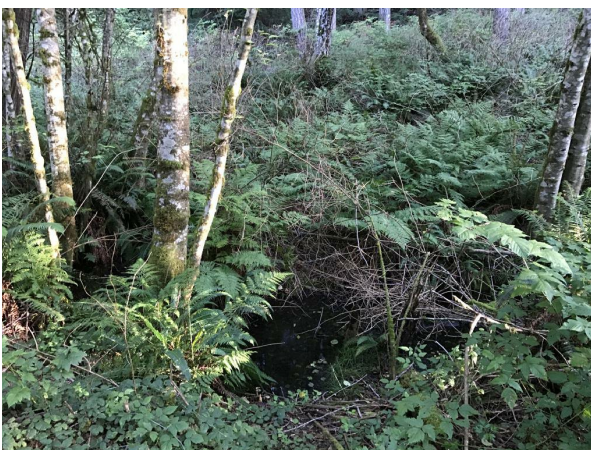
FIGURE 116

Photo: Placemark 102
Date (YYYY MM DD): 2021 07 16
Location: **Smales Cr watershed, north side of trail west of end of Reed Road.**
View direction: North
Description:
 Standing water along 100 m of ditch.

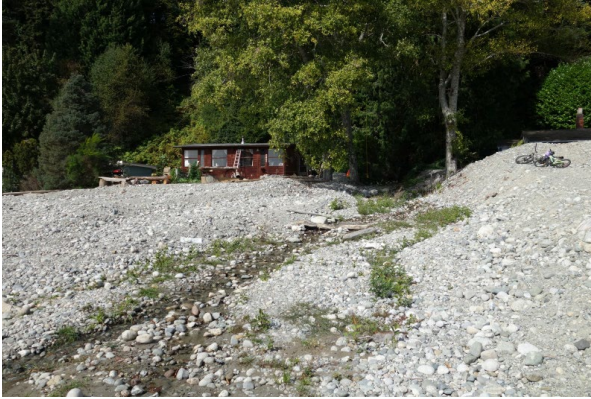
FIGURE 117

Photo: DSC00026
Date (YYYY MM DD): 2020 08 26
Location: **Whittaker Cr, km 0.0**
View direction: Upstream
Description:

Widespread aggradation near the mouth of Whittaker Creek following a washout of Lower Road.

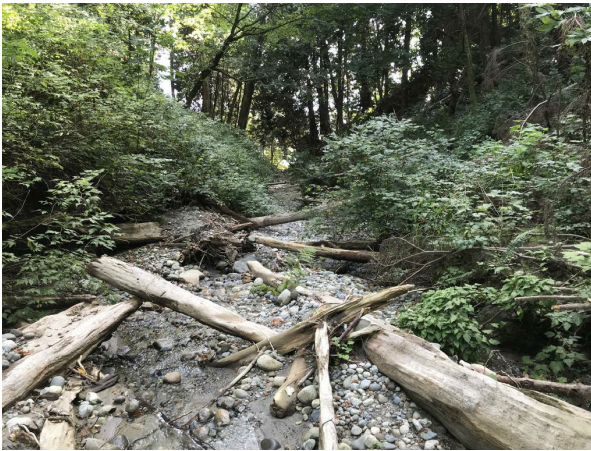
FIGURE 118

Photo: Placemark 140
Date (YYYY MM DD): 2021 07 16
Location: **Whittaker Cr, km 0.1**
View direction: Downstream
Description:

Stream conditions post-flood and road washout.

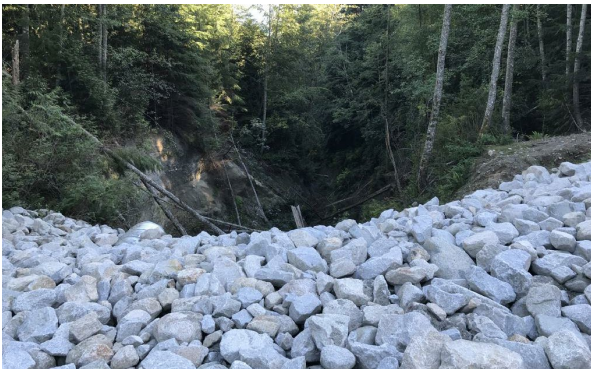
FIGURE 119

Photo: Placemark 99
Date (YYYY MM DD): 2021 07 16
Location: **Whittaker Cr, km 0.4**
View direction: Downstream
Description:

View below repaired crossing at Lower Road. A large volume of riprap was installed below crossing.

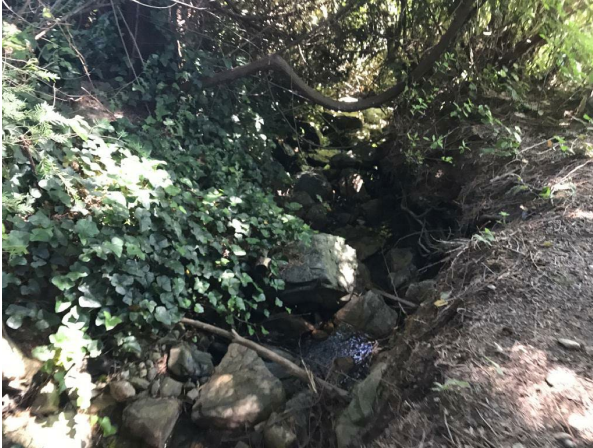
FIGURE 121

Photo: Placemark 36
Date (YYYY MM DD): 2021 07 16
Location: **Higgs Br, km 0.05**
View direction: Upstream
Description:
Incised channel with eroding banks near trail.

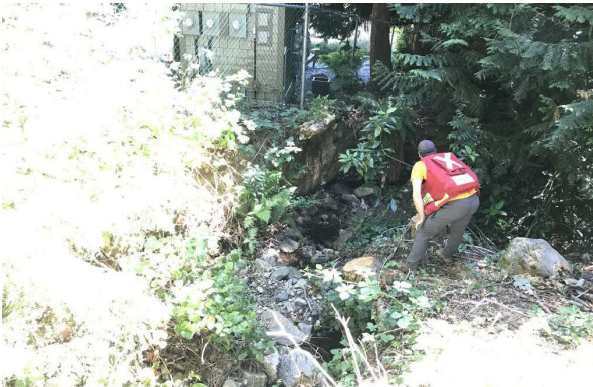
FIGURE 123

Photo: Placemark 34
Date (YYYY MM DD): 2021 07 16
Location: **Higgs Br, km 0.1**
View direction: Downstream
Description:
Undercut bank poses a risk to utility building adjacent to channel.

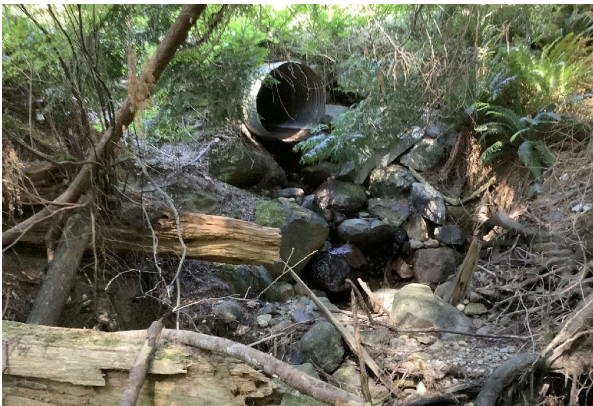
FIGURE 124

Photo: Placemark 72
Date (YYYY MM DD): 2021 07 16
Location: **Higgs Br, km 0.1**
View direction: Upstream
Description:
1,000 mm diameter culvert at Lower Road. Incised channel below road.

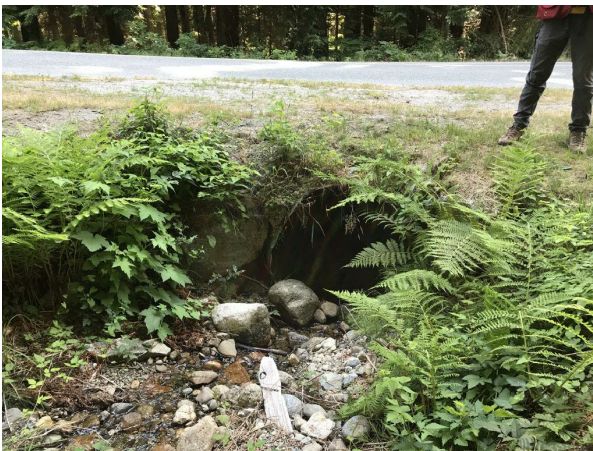
FIGURE 127

Photo: Placemark 38
Date (YYYY MM DD): 2021 07 16
Location: **Higgs Br, km 0.3**
View direction: Downstream
Description:
Lower Road culvert inlet.

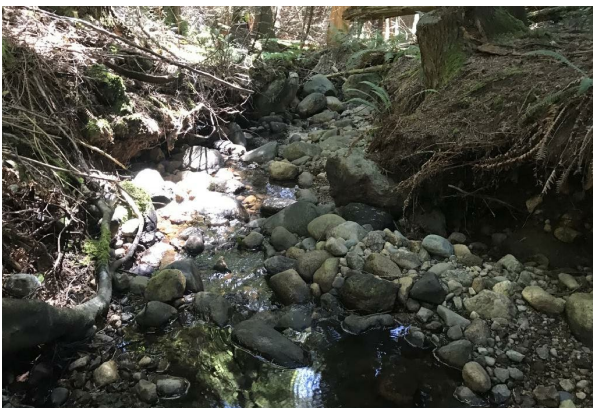
FIGURE 128

Photo: Placemark 41
Date (YYYY MM DD): 2021 07 16
Location: **Higgs Br, km 0.75**
View direction: Upstream
Description:
Incised channel near farm.

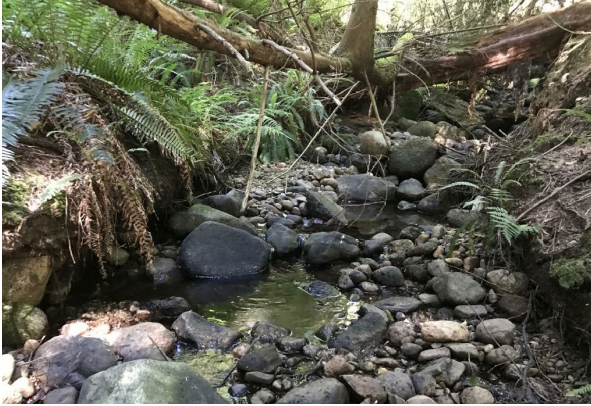
FIGURE 129

Photo: Placemark 41
Date (YYYY MM DD): 2021 07 16
Location: **Higgs Br, km 0.75**
View direction: Downstream
Description:
Incised channel near farm.

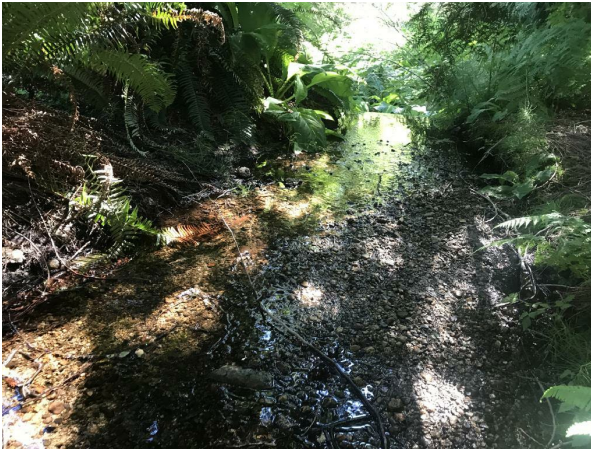
FIGURE 130

Photo: Placemark 49
Date (YYYY MM DD): 2021 07 16
Location: **Higgs Br, km 1.3**
View direction: Downstream
Description:
Weir and pond infilled with sediment.

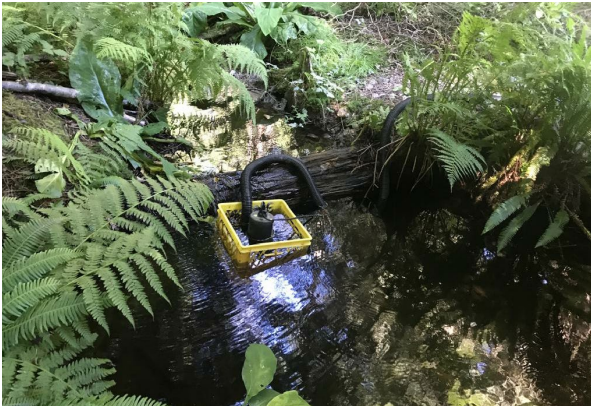
FIGURE 131

Photo: Placemark 49
Date (YYYY MM DD): 2021 07 16
Location: **Higgs Br, km 1.3**
View direction: Upstream
Description:
Submersible pump in milk crate at location of weir and pond infilled with sediment. Water licence C070726.

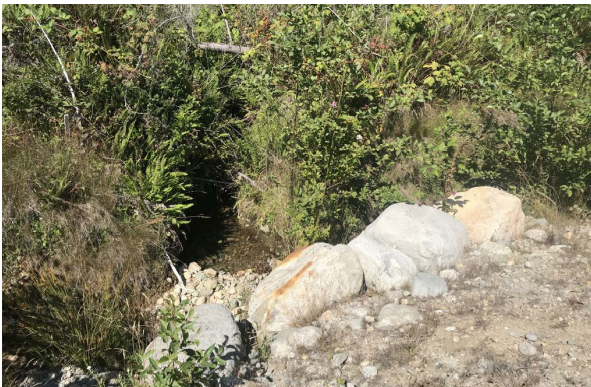
FIGURE 132

Photo: Placemark 46
Date (YYYY MM DD): 2021 07 16
Location: **Higgs Br, km 1.6**
View direction: Upstream
Description:
View below Harman Road culvert.

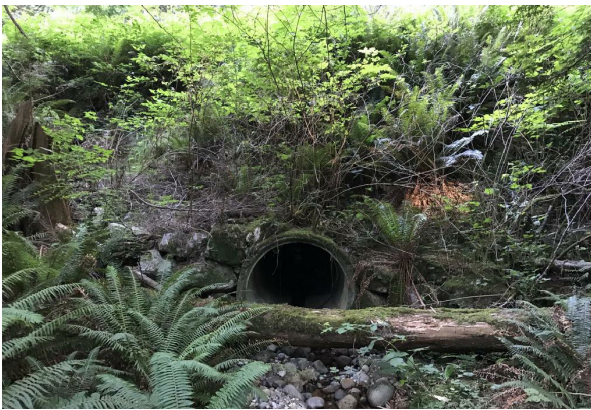
FIGURE 134

Photo: Placemark 62
Date (YYYY MM DD): 2021 07 16
Location: **Slater Cr, km 0.4**
View direction: Downstream
Description:
Lower Road 1200 mm diameter concrete culvert.

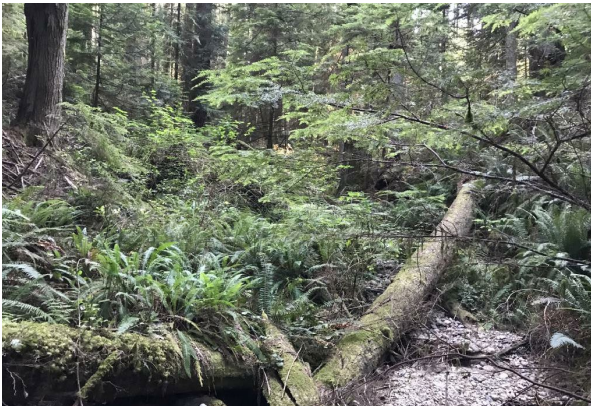
FIGURE 135

Photo: Placemark 62
Date (YYYY MM DD): 2021 07 16
Location: **Slater Cr, km 0.45**
View direction: Upstream
Description:
Bedrock along channel noted.

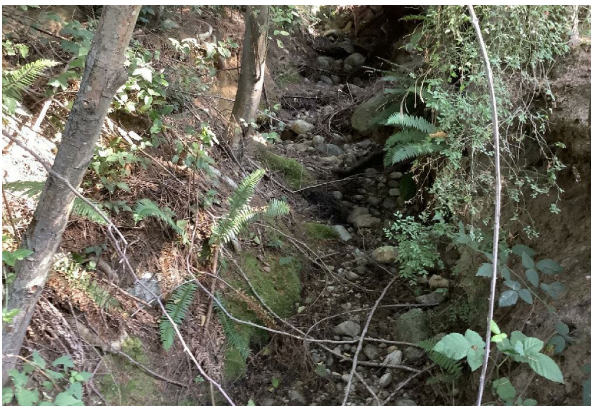
FIGURE 136

Photo: Placemark 101
Date (YYYY MM DD): 2021 07 16
Location: **Slater Cr, km 1.0**
View direction: Upstream
Description:
Incised channel above Sunshine Coast Highway and 900 mm diameter culvert.

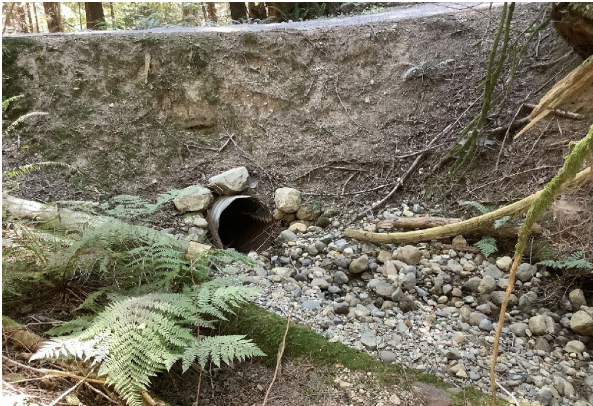
FIGURE 138

Photo: Placemark 124
Date (YYYY MM DD): 2021 07 16
Location: **Slater Cr, km 1.4**
View direction: Downstream
Description:
600 mm diameter culvert at Porter Road.

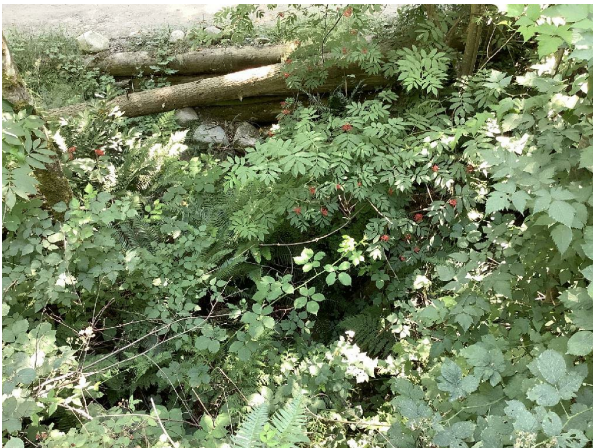
FIGURE 140

Photo: Placemark 137
Date (YYYY MM DD): 2021 07 16
Location: **Slater Cr, km 2.1**
View direction: Upstream
Description:
Wood bridge near driveway on Pixton Road.

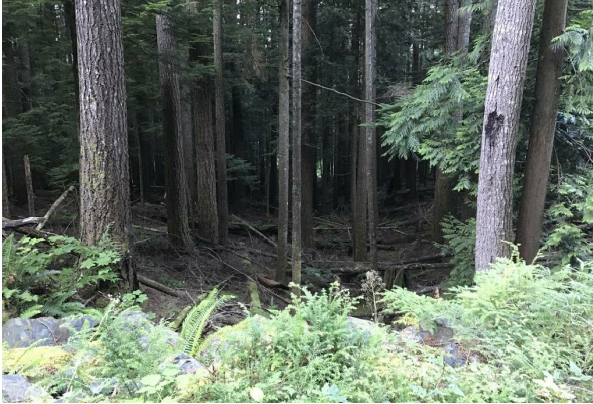
FIGURE 141

Photo: Placemark 153
Date (YYYY MM DD): 2021 07 16
Location: **Slater Cr Tributary 1.2,**
 km 3.3
View direction: Downstream
Description:
 NCD in gully.

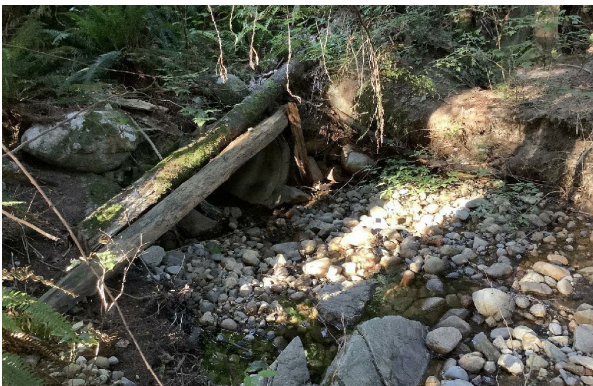
FIGURE 144

Photo: Placemark 95
Date (YYYY MM DD): 2021 07 16
Location: **Slater Cr, km 0.3**
View direction: Downstream
Description:
 1,200 mm diameter concrete culvert with log at inlet. Evidence of sediment accumulation at inlet.

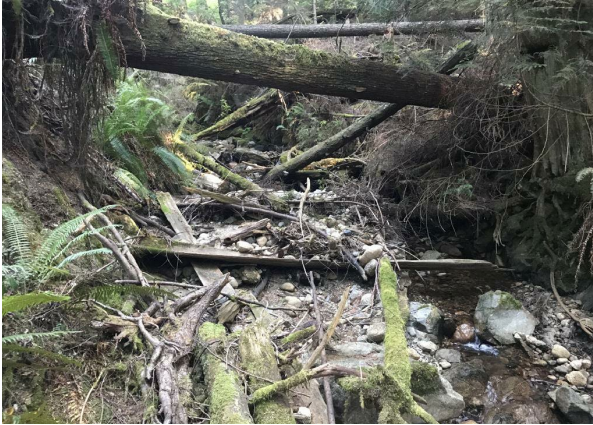
FIGURE 145

Photo: Placemark 56
Date (YYYY MM DD): 2021 07 16
Location: **Molyneux Cr, km 0.35**
View direction: Upstream
Description:
Incised channel above Lower Road. Heavy wood load.

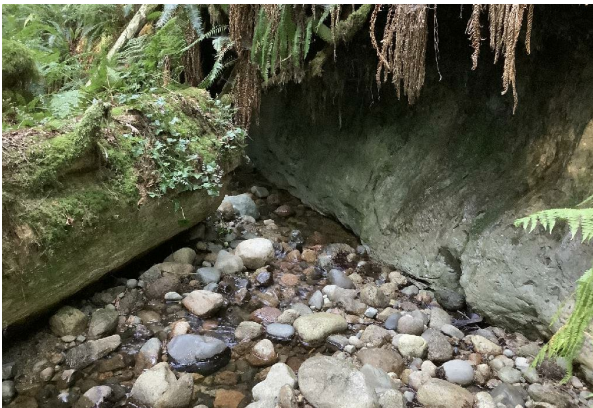
FIGURE 146

Photo: Placemark 97
Date (YYYY MM DD): 2021 07 16
Location: **Molyneux Cr, km 0.5**
View direction: Upstream
Description:
Exposed clay till along stream bank.

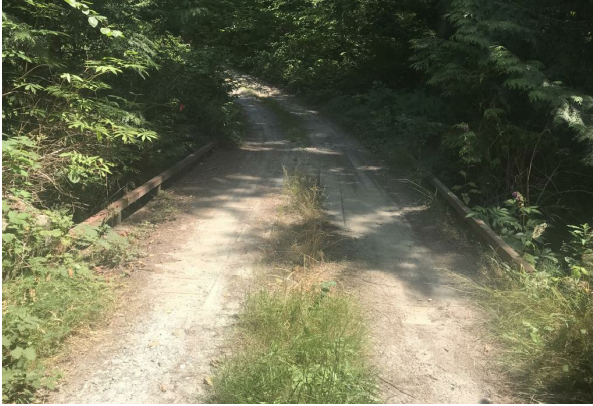
FIGURE 149

Photo: Placemark 60
Date (YYYY MM DD): 2021 07 16
Location: **Molyneux Cr**
Tributary 1.1, km 1.4
View direction: East.
Description: Private bridge near end of Porter Road. No flow in stream.

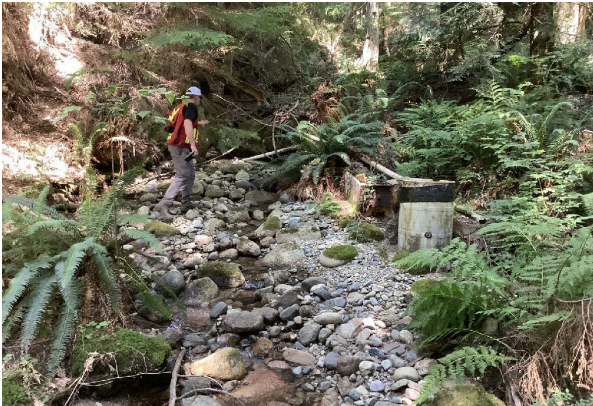
FIGURE 150

Photo: Placemark 122
Date (YYYY MM DD): 2021 07 16
Location: **Molyneux Cr**
Tributary 1.2, km 1.3
View direction: Upstream
Description: Water intake in apparent disrepair.

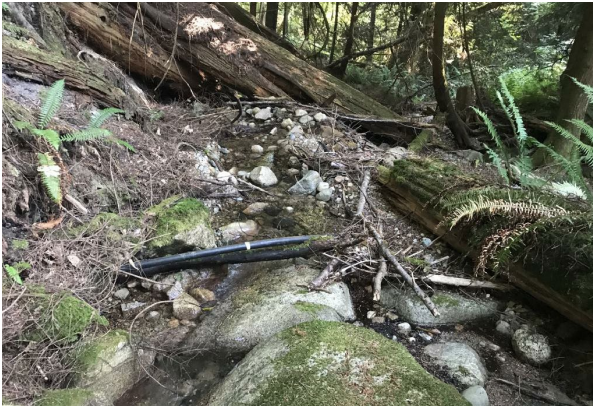
FIGURE 154

Photo: Placemark 111
Date (YYYY MM DD): 2021 07 16
Location: **Molyneux Cr
Tributary 1.2, km 1.75**
View direction: Downstream
Description:
Exposed water line in channel.

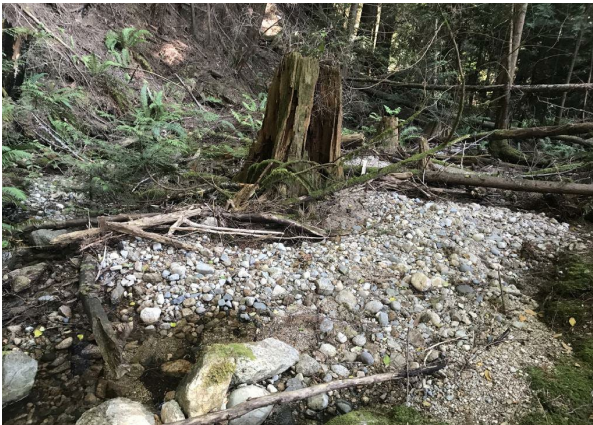
FIGURE 156

Photo: Placemark 112
Date (YYYY MM DD): 2021 07 16
Location: **Molyneux Cr
Tributary 1.2, km 1.7**
View direction: Downstream
Description:
Location of former water intake above log jam and buried by gravel. Various pipes and barrel noted in area.

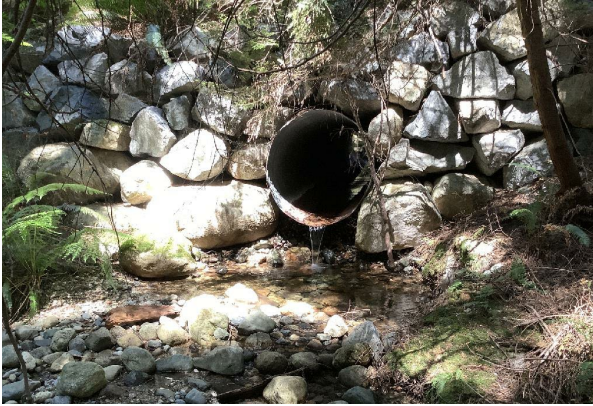
FIGURE 157

Photo: Placemark 125
Date (YYYY MM DD): 2021 07 16
Location: **Molyneux Cr
 Tributary 2, km 1.3**
View direction: Upstream
Description:
 1,200 mm diameter culvert.

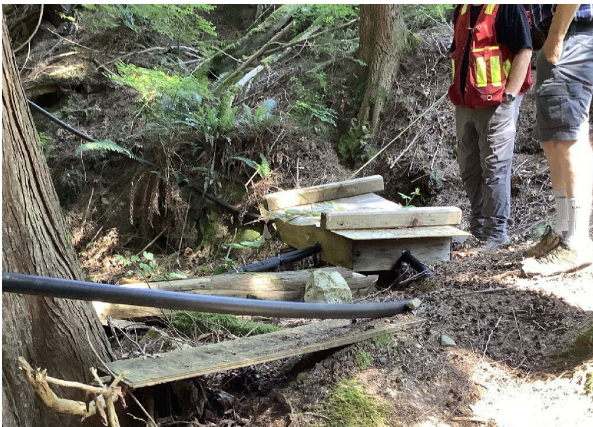
FIGURE 160

Photo: Placemark 93
Date (YYYY MM DD): 2021 07 16
Location: **Molyneux Cr
 Tributary 2, km 1.35**
View direction: Downstream
Description:
 Water supply infrastructure along creek.
 Licence C114609.

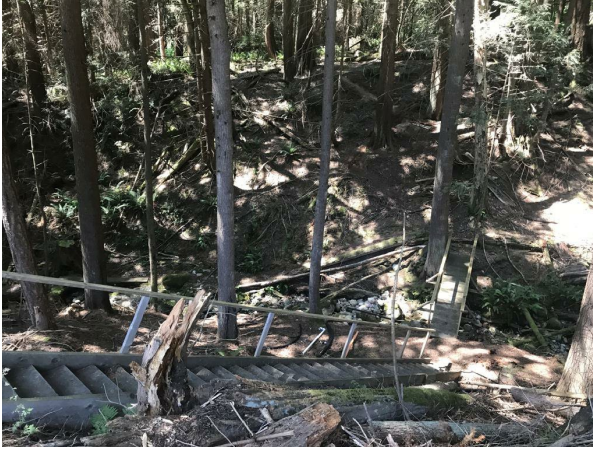
FIGURE 161

Photo: Placemark 94
Date (YYYY MM DD): 2021 07 16
Location: **Molyneux Cr
Tributary 2, km 1.5**
View direction: West
Description:
Private stairs and bridge across creek.

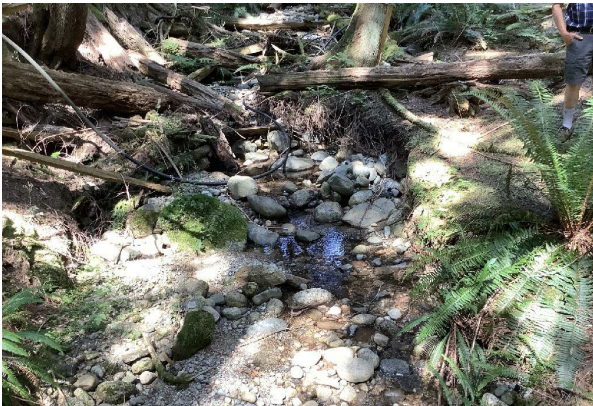
FIGURE 163

Photo: Placemark 132
Date (YYYY MM DD): 2021 07 16
Location: **Molyneux Cr
Tributary 2, km 1.55**
View direction: Upstream
Description:
Water line along creek.

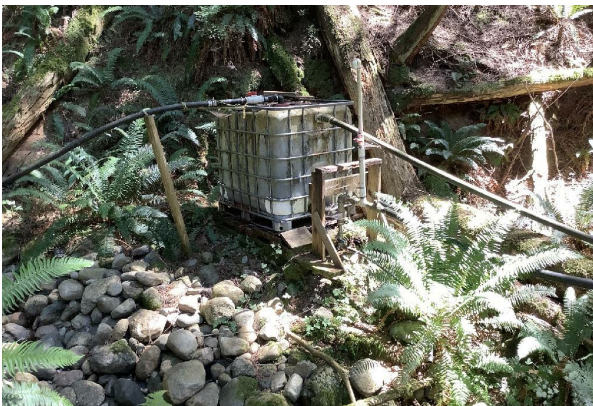
FIGURE 164

Photo: Placemark 133
Date (YYYY MM DD): 2021 07 16
Location: **Molyneux Cr
Tributary 2, km 1.6**
View direction: Upstream
Description:
Water supply infrastructure along creek.
