BC TIMBER SALES CHINOOK BUSINESS AREA

MT. ELPHINSTONE SOUTH
WATERSHED ASSESSMENT:
PHASES 1 & 2 (VOLUME 2)

Polar File: 740201
MARCH 2023

APPENDIX F: SELECTED PHOTOS

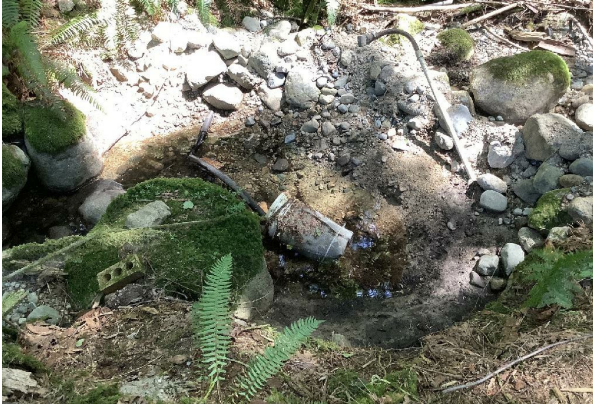
FIGURE 165

Photo: Placemark 134
Date (YYYY MM DD): 2021 07 16
Location: **Molyneux Cr
 Tributary 2, km 1.6**
View direction: Downstream
Description:
 Intake in small pool. Licence C118817.

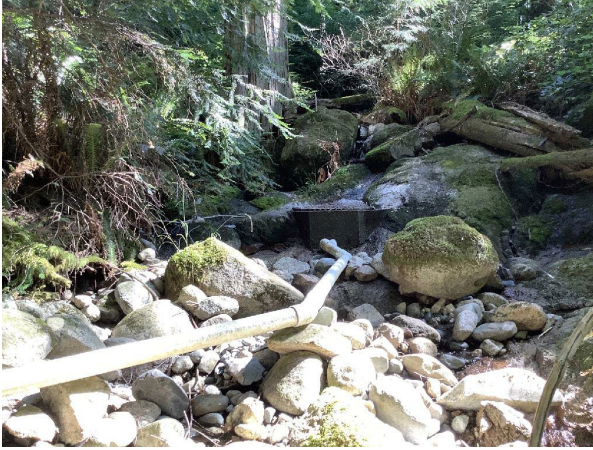
FIGURE 169

Photo: Placemark XX
Date (YYYY MM DD): 2021 07 16
Location: **Molyneux Cr**
Tributary 1.2, km 2.5
View direction: Upstream

Description:
 Concrete intake in channel with pvc distribution pipe below. Intake may be vulnerable to sediment loading.

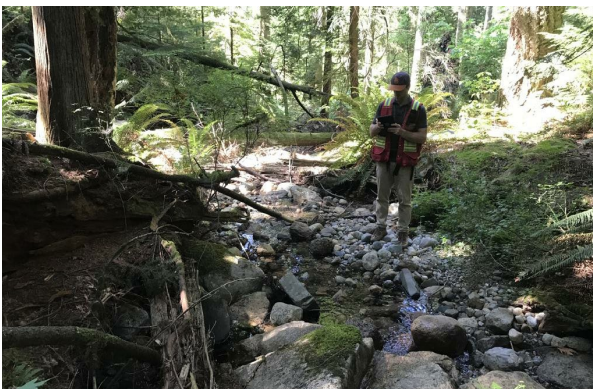
FIGURE 171

Photo: Placemark 74
Date (YYYY MM DD): 2021 07 16
Location: **Molyneux Cr**
Tributary 1.2, km 2.6
View direction: Upstream

Description:
 Heavy blowdown from edge of harvested block to the east.

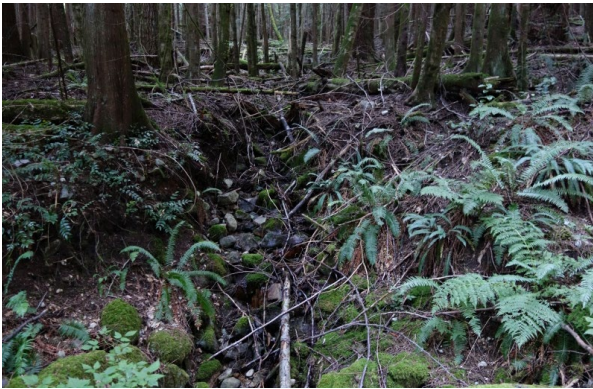
FIGURE 173

Photo: Placemark 33
Date (YYYY MM DD): 2021 07 16
Location: **Molyneux Cr
Tributary 1.2, km 2.8**
View direction: Upstream
Description:
Bouldery channel above log bridge.

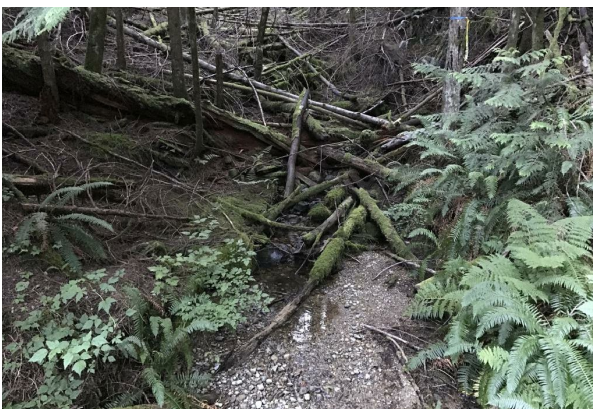
FIGURE 175

Photo: Placemark 148
Date (YYYY MM DD): 2021 07 16
Location: **Molyneux Cr
Tributary 1.2.7, km 4.1**
View direction: Upstream
Description:
S6 channel above 900 mm culvert.

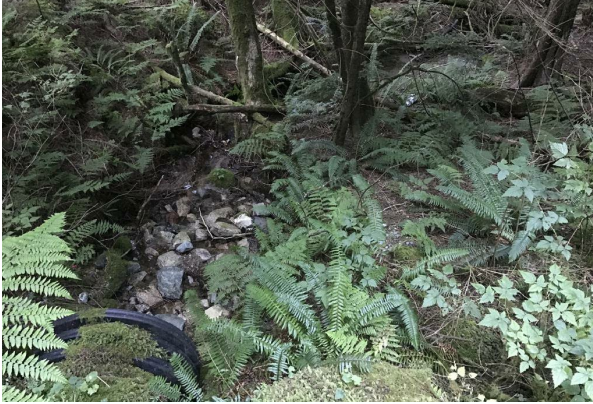
FIGURE 176

Photo: Placemark 147
Date (YYYY MM DD): 2021 07 16
Location: **Molyneux Cr
Tributary 1.2.8.1, km
4.1**
View direction: Upstream
Description:
S6 channel above 900 mm culvert.

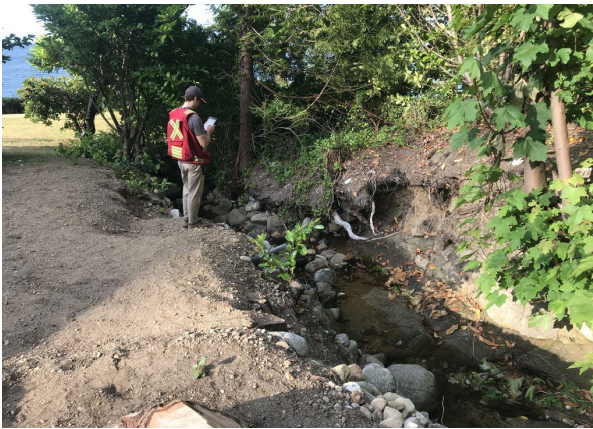
FIGURE 181

Photo: Placemark 149
Date (YYYY MM DD): 2021 07 16
Location: **Joe Smith Cr, km 0.05**
View direction: Upstream
Description:
Eroding channel along private property.

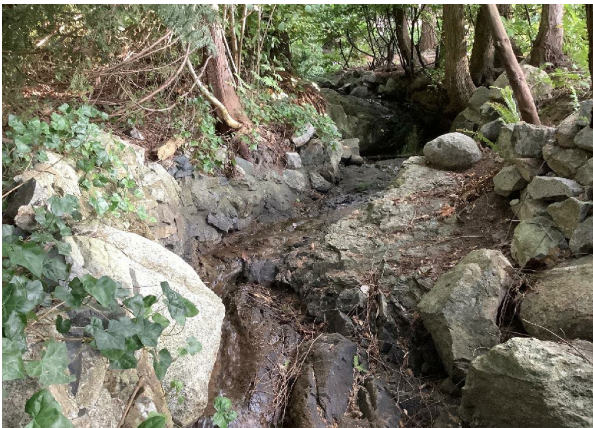
FIGURE 182

Photo: Placemark 115
Date (YYYY MM DD): 2021 07 16
Location: **Joe Smith Cr, km 0.05**
View direction: Downstream
Description:
Eroding channel along private property.

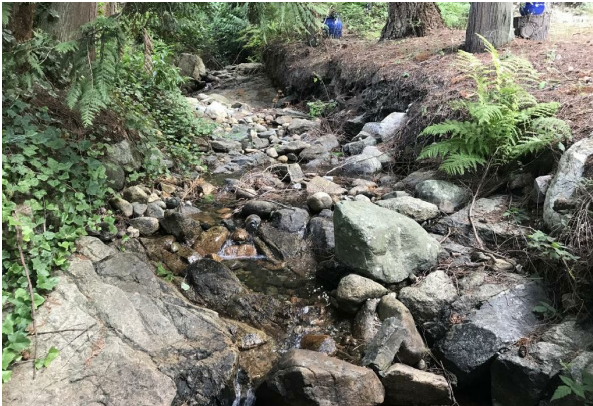
FIGURE 185

Photo: Placemark 117
Date (YYYY.MM.DD): 2021 07 16
Location: **Joe Smith Cr, km 0.2**
View direction: Upstream
Description:
Exposed bedrock along channel.

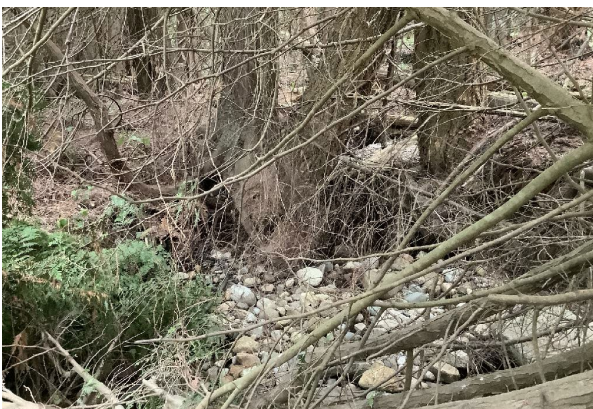
FIGURE 187

Photo: Placemark 153
Date (YYYY.MM.DD): 2021 07 16
Location: **Joe Smith Cr, km 0.25**
View direction: Downstream
Description:
Undercut banks may pose blowdown risk.

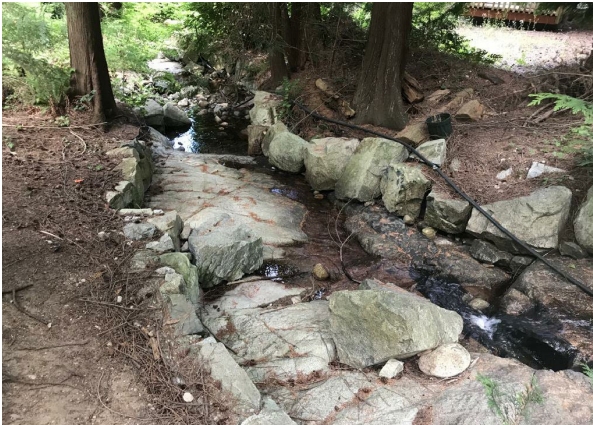
FIGURE 189

Photo: Placemark 120
Date (YYYY MM DD): 2021 07 16
Location: **Joe Smith Cr, km 0.3**
View direction: Upstream

Description:
Culvert outlet at Lower Road. Note water distribution pipe in culvert. Intake of pipe approximately 10 m above road (not apparently in use).

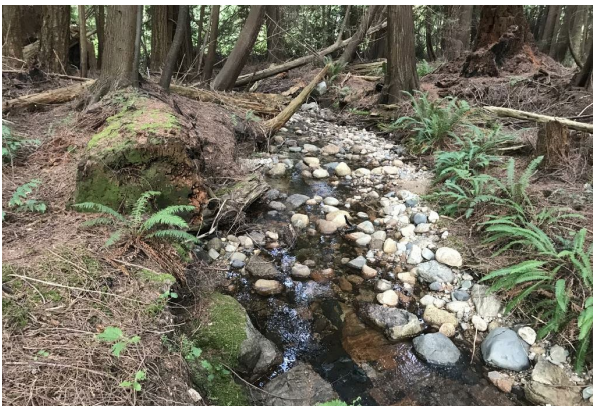
FIGURE 191

Photo: Placemark 121
Date (YYYY MM DD): 2021 07 16
Location: **Joe Smith Cr, km 0.35**
View direction: Upstream

Description:
Sediment trapped by debris above Lower Road.

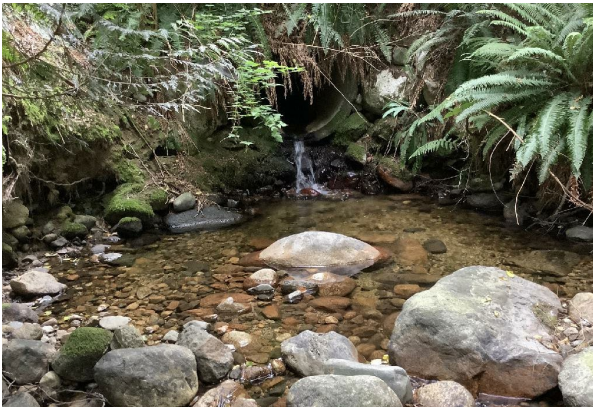
FIGURE 198

Photo: Placemark 162
Date (YYYY MM DD): 2021 07 16
Location: **Joe Smith Cr, km 0.70**
View direction: Downstream
Description:

Five 600 mm diameter culverts on private driveway.

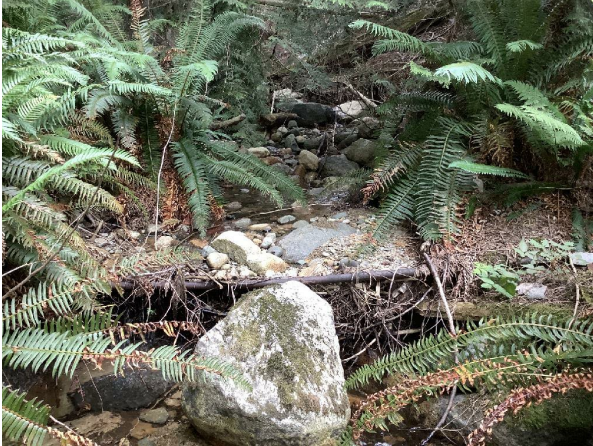
FIGURE 200

Photo: Placemark 160
Date (YYYY MM DD): 2021 07 16
Location: **Joe Smith Cr, km 0.85**
View direction: Upstream
Description:

View below Sunshine Coast Highway.

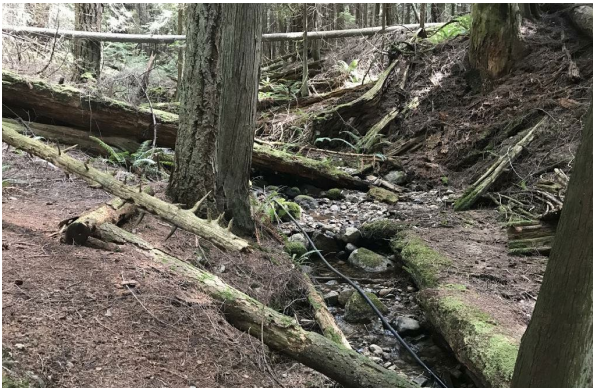
FIGURE 201

Photo: Placemark 163
Date (YYYY MM DD): 2021 07 16
Location: **Joe Smith Cr, km 1.10**
View direction: Upstream
Description:
View above Pixton Road culvert.

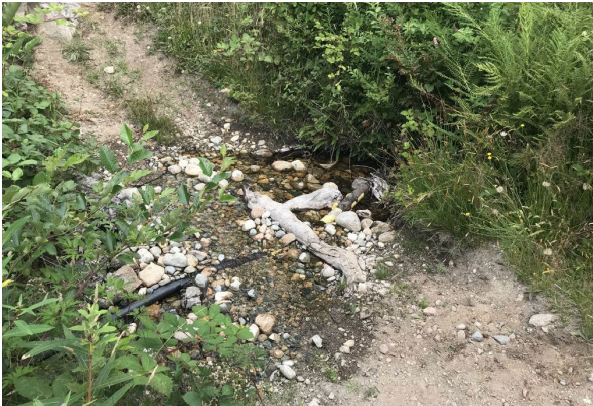
FIGURE 202

Photo: Placemark 224
Date (YYYY MM DD): 2021 07 16
Location: **Joe Smith Cr, km 1.50**
View direction: Upstream
Description:
Water distribution line along channel.

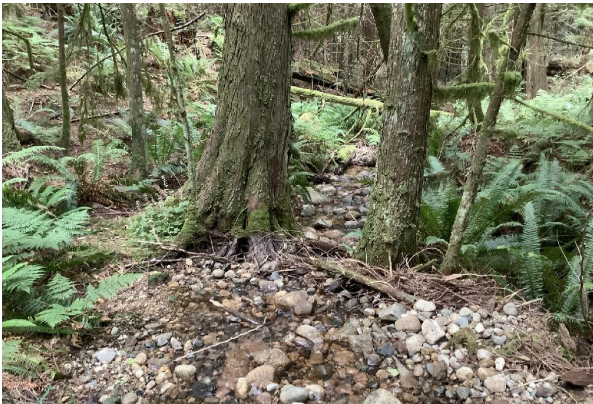
FIGURE 203

Photo: Placemark 134
Date (YYYY MM DD): 2021 07 16
Location: **Joe Smith Cr, km 1.70**
View direction: West
Description:
Water distribution line along stream at hydro right-of-way.

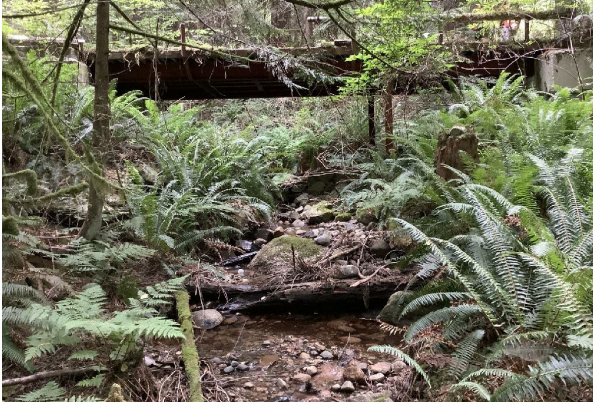
FIGURE 204

Photo: Placemark XX
Date (YYYY MM DD): 2021 07 16
Location: **Joe Smith Cr, km 1.80**
View direction: Upstream
Description:
Aggraded channel.

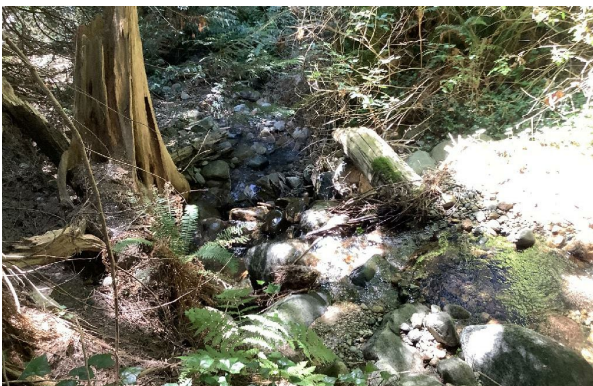
FIGURE 207

Photo: Placemark 160
Date (YYYY MM DD): 2021 07 16
Location: **Clough Cr, km 0.0**
View direction: West
Description:
Mouth of creek.

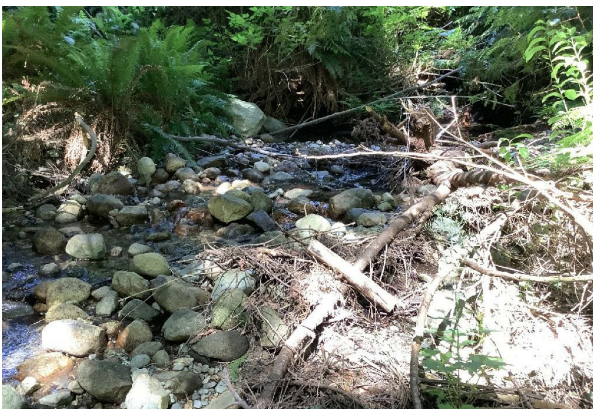
FIGURE 210

Photo: Placemark 191
Date (YYYY MM DD): 2021 07 16
Location: **Clough Cr, km 0.3**
View direction: Upstream
Description:
Concrete weir, does not appear to be functional.

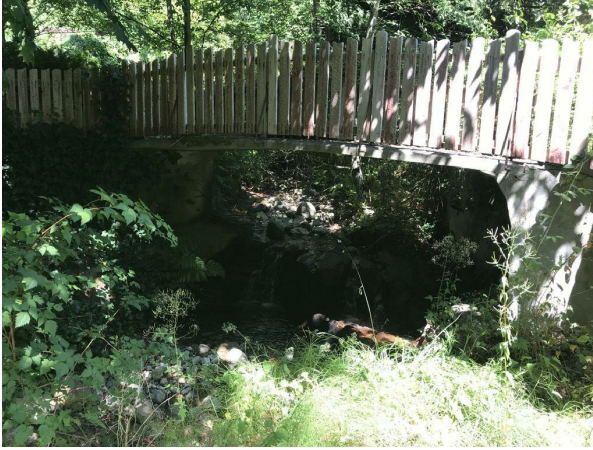
FIGURE 212

Photo: Placemark 190
Date (YYYY MM DD): 2021 07 16
Location: **Clough Cr, km 0.3**
View direction: Downstream
Description:
Channel below Lower Road.

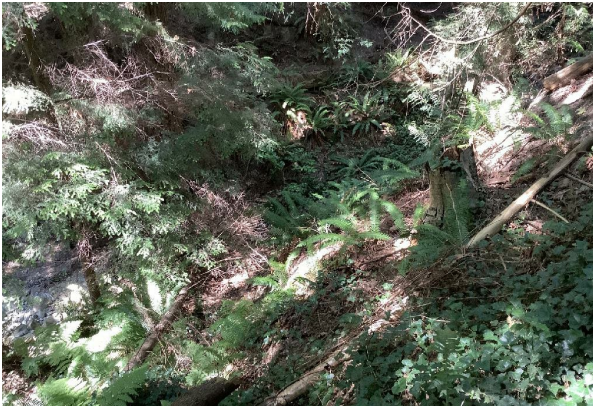
FIGURE 213

Photo: Placemark 162
Date (YYYY MM DD): 2021 07 16
Location: **Clough Cr, km 0.35**
View direction: Upstream
Description:
View above Lower Road to private foot bridge.

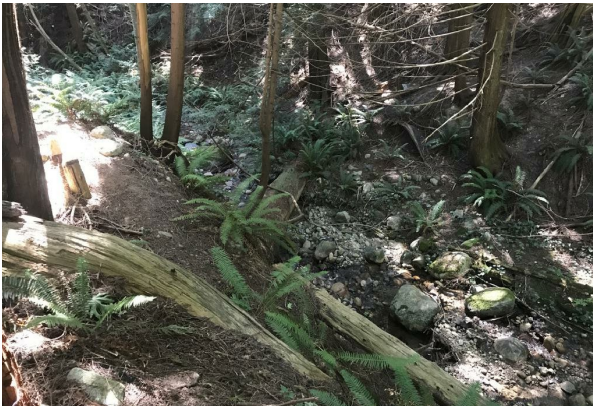
FIGURE 214

Photo: Placemark 192
Date (YYYY MM DD): 2021 07 16
Location: **Clough Cr, km 0.6**
View direction: West
Description:
10 m deep ravine.

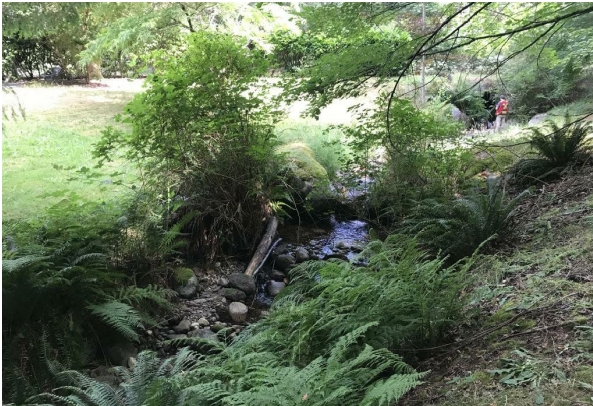
FIGURE 221

Photo: Placemark 141
Date (YYYY MM DD): 2021 07 16
Location: **Clough Cr, km 1.2**
View direction: Downstream
Description:

Suspected scar on tree associated with the 1983 debris flow. Scar is up to 3 m above current streambed.

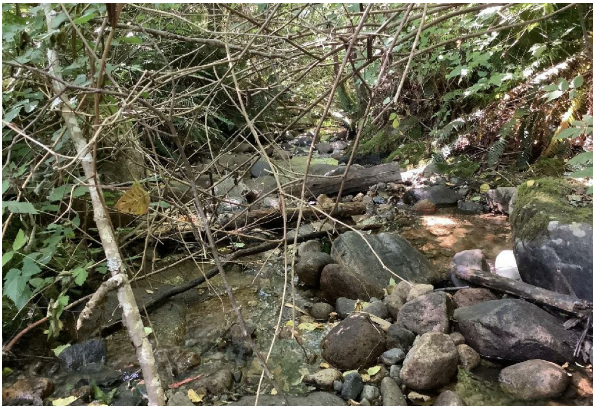
FIGURE 222

Photo: Placemark 138
Date (YYYY MM DD): 2021 07 16
Location: **Clough Cr, km 1.2**
View direction: Upstream
Description:

View across property affected by the 1983 debris flow.

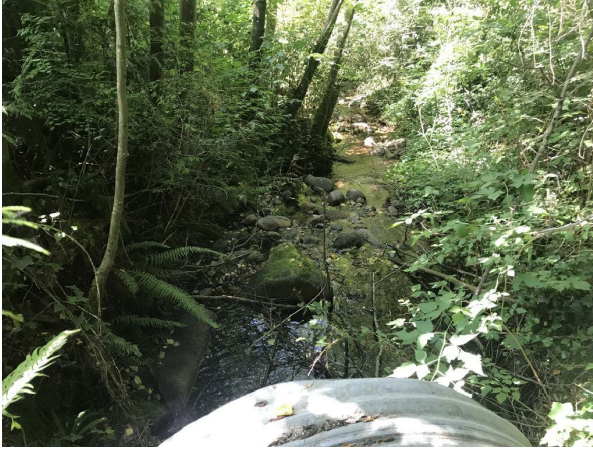
FIGURE 224

Photo: Placemark 174
Date (YYYY MM DD): 2021 07 16
Location: **Clough Cr, km 1.45**
View direction: Upstream
Description:

View above Orange Road culvert.

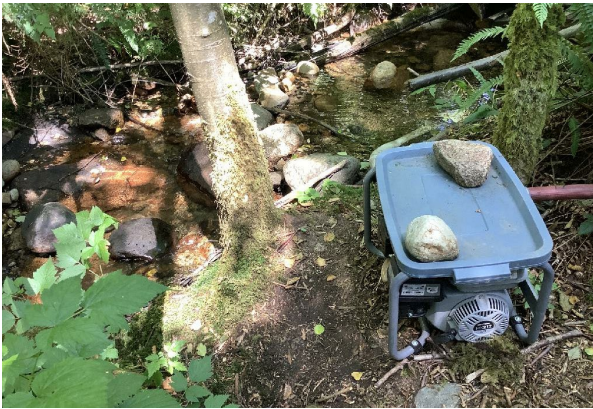
FIGURE 225

Photo: Placemark 144
Date (YYYY MM DD): 2021 07 16
Location: **Clough Cr, km 1.45**
View direction: Downstream
Description:
View below Orange Road culvert.

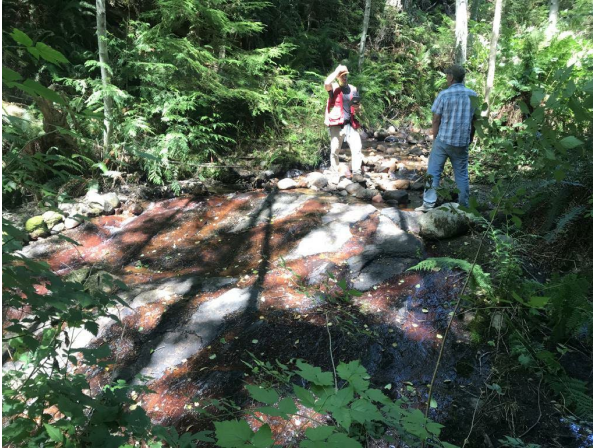
FIGURE 228

Photo: Placemark 178
Date (YYYY MM DD): 2021 07 16
Location: **Clough Cr, km 1.6**
View direction: Downstream
Description:
Localized riparian clearing along private property.

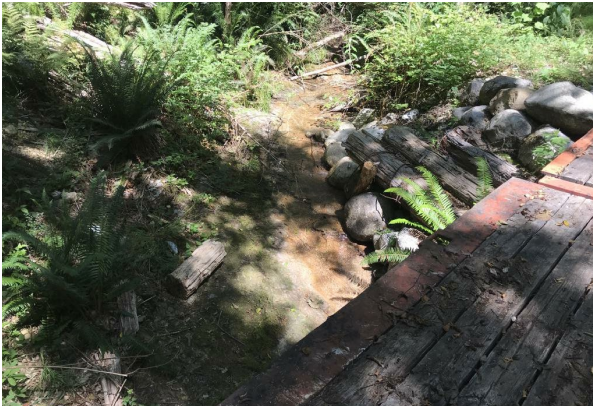
FIGURE 230

Photo: Placemark 179
Date (YYYY MM DD): 2021 07 16
Location: **Clough Cr, km 1.2**
View direction: Upstream
Description:
Water intake near hydro right-of-way.
Distribution line runs parallel to creek to private property.
